Prepared by the
**MONTACHUSETT REGIONAL
PLANNING COMMISSION
(MRPC)**

Route 117 Corridor Profile Town of Lancaster, Massachusetts

September 2013

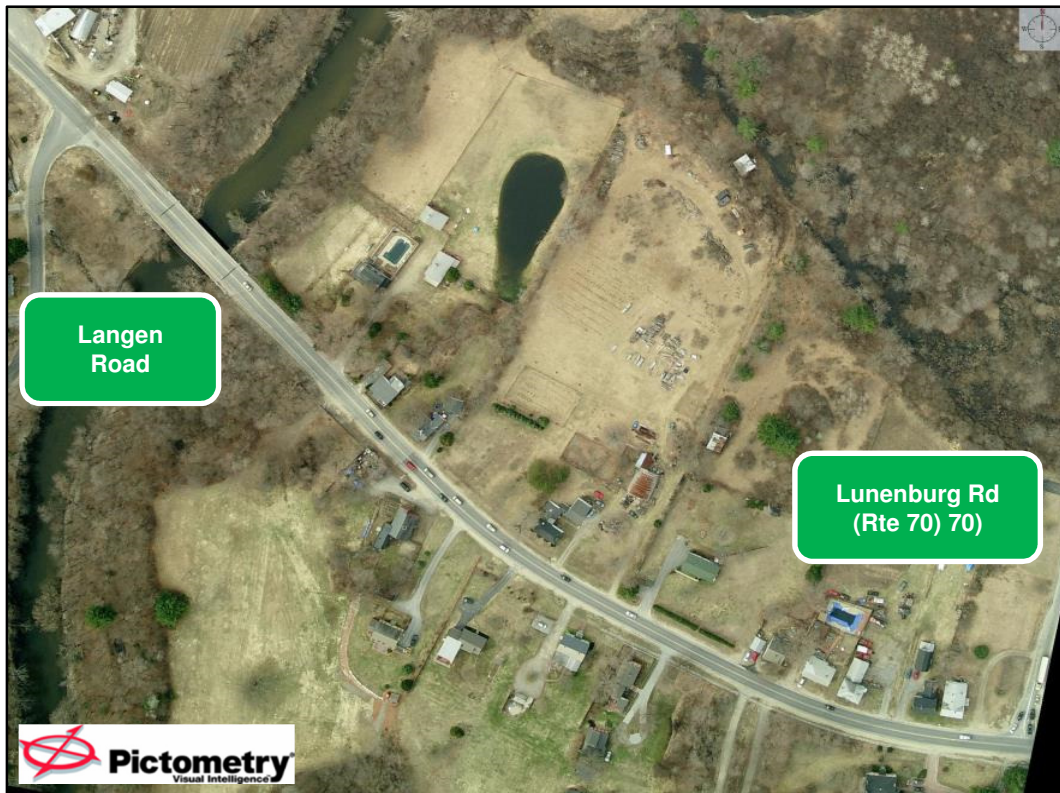
Figure 4-4: Langen Rd in Relation to Lunenburg Rd (west to east)

Of the 13 intersection crashes, 2012 saw the highest percentage of crashes with 46% while 2010 saw 38% of the crashes. The hours of 3:00 – 4:00 PM and 5:00 – 6:00 PM saw 31% of the crashes each. 23% of the intersection crashes resulted in an injury crash. Rear-end crashes accounted for the highest crash manner at 77% of the total crashes.

Adverse road surface conditions were reported on 8% of the crash reports. Adverse weather conditions were reported on 15% of the crash reports. Adverse ambient light conditions were reported on 15% of the crash reports. Crashes occurred at a higher percentage of 69% during cold months while 31% of the crashes occurred during warm months.

An analysis of the crash narratives found in the crash reports revealed that at-fault vehicle driver error the most significant contributing factor in 77% of the crashes. Two quotes from two different crash reports provide examples of the types of driver error that occurred in these crashes:

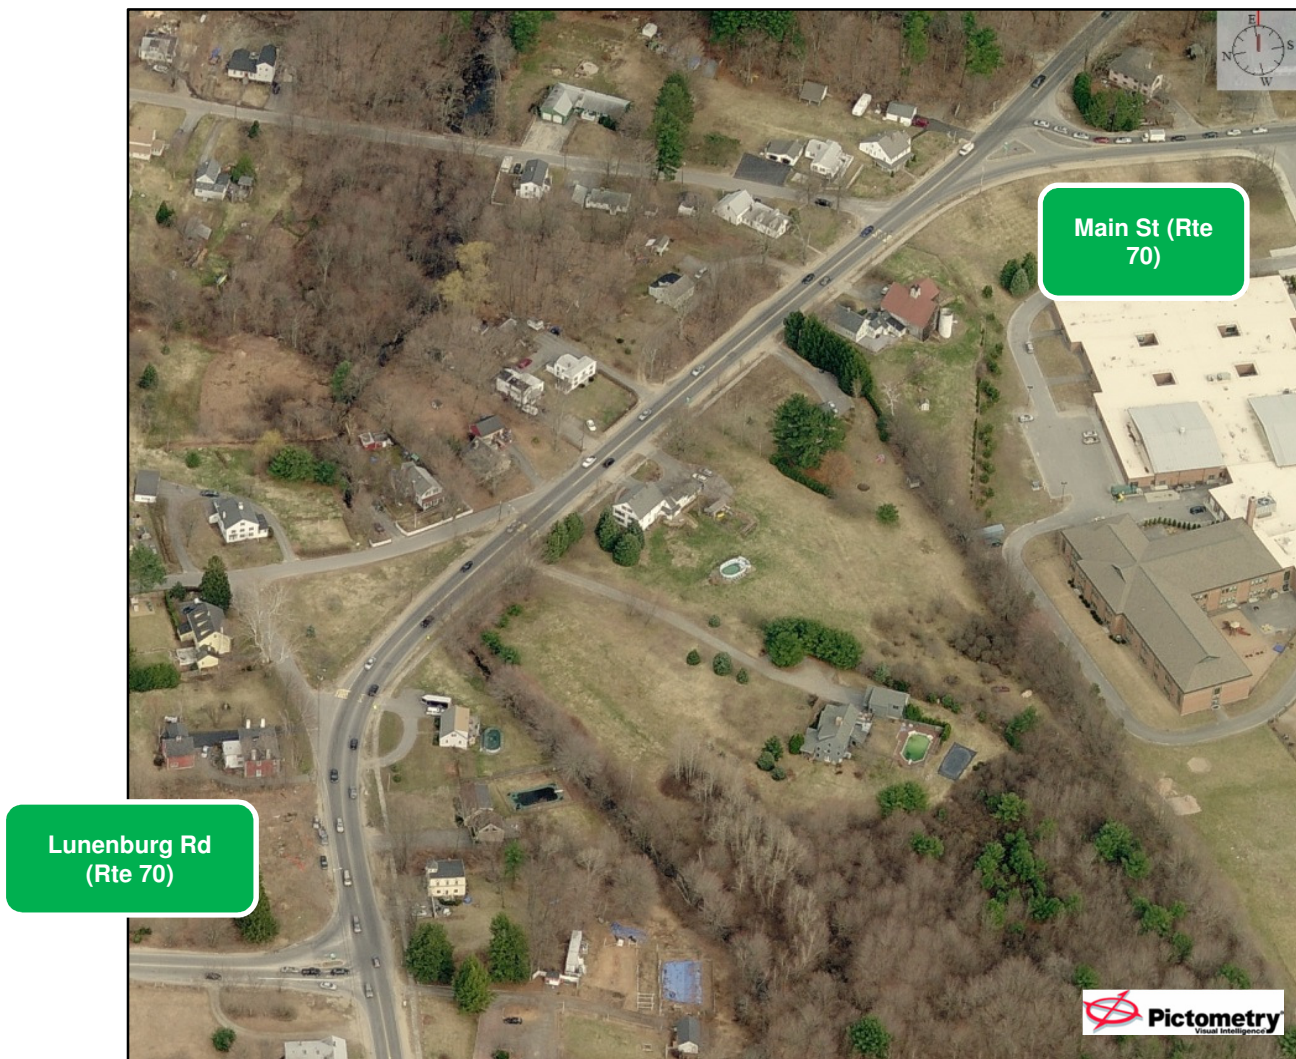
Figure 4-5: Lunenburg Road (Route 70) & Main Street (Route 70) in
Relation to Each Other (west to east)

Twenty three (23) crashes occurred at the Main Street (Route 117) and Lunenburg Road (Route 70) intersection. 26% of the crashes resulted in an injury crash while the remaining 74% of crashes were property damage only crashes (see the Crash Diagram in the Appendix). This intersection will most likely qualify as a high crash location as the EPDO total for the cluster of crashes, which totals 47, would place the intersection within the top 5% of crash clusters in the MRPC region.

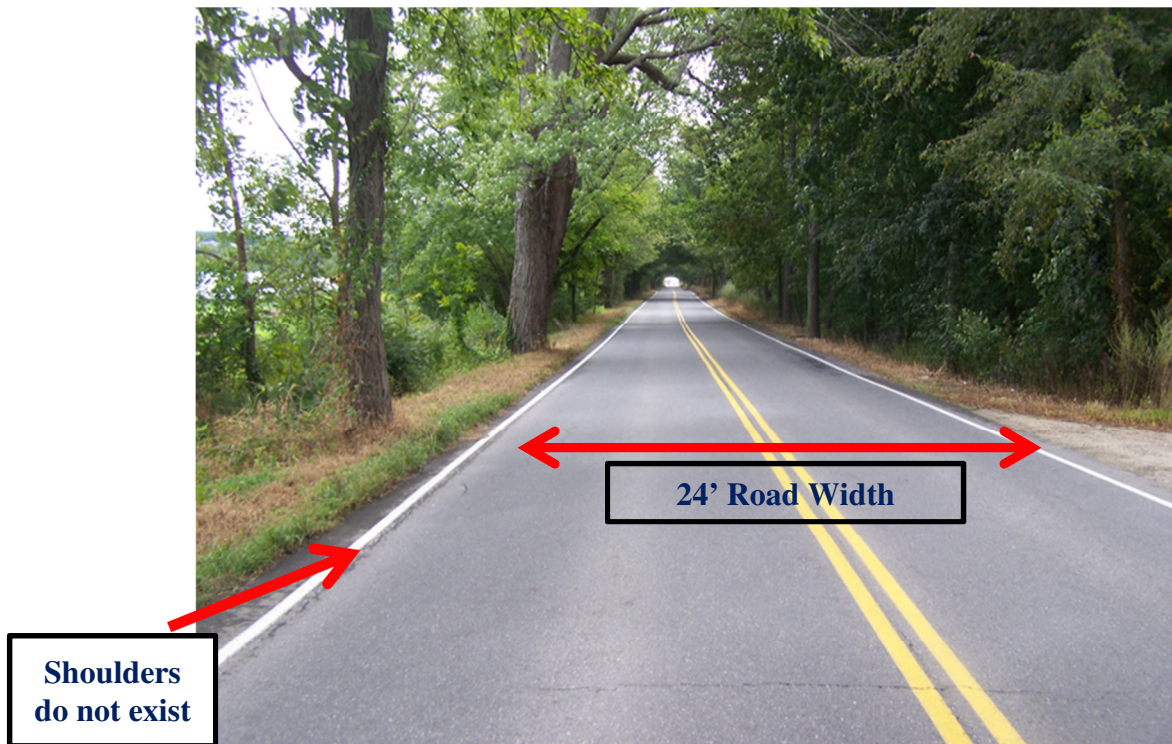
“Bolton Flats” Area of Corridor

One exception is the Bolton Flats area in which road width and ROW width are both 24’, leaving no room for additional width for bike and pedestrian use. Added signage would be ideal in this location reminding motorists to “Share the Road”.

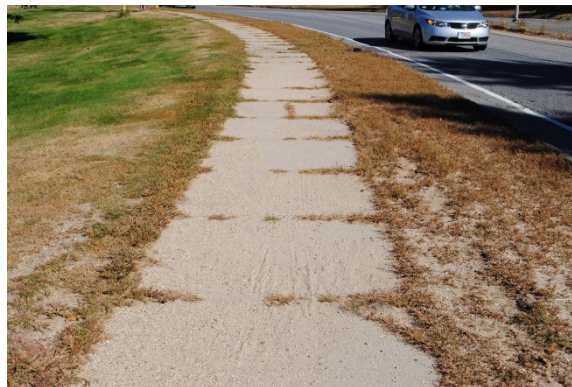
Sidewalks – The major roadways (Route 117 and Route 70) had sidewalks within the focus area. This includes the area of the Elementary School. Overall, the sidewalks are in good condition with the exception of a few areas that had some grass patches. (see photo below)

Vegetation along sidewalk

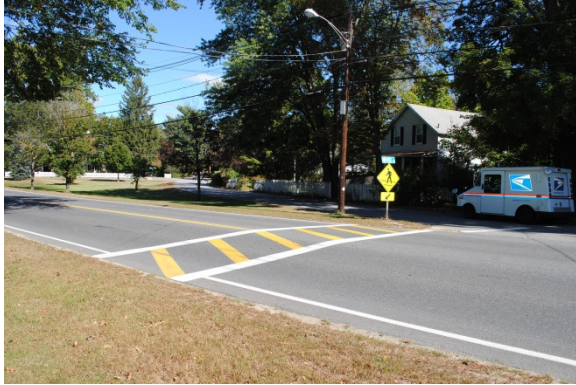
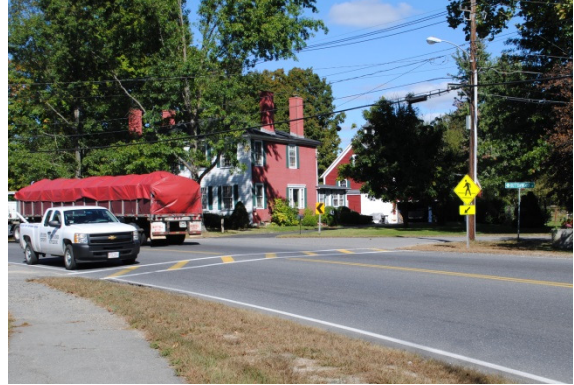
Crosswalks – There were a handful of crosswalks along the roadways in this area. Most of these, however, do not have curb cuts and are located in areas without sidewalks. Crosswalk signage is present and visible.

Crosswalks and signage along Route 117 – No curb cuts or direct connection with sidewalk

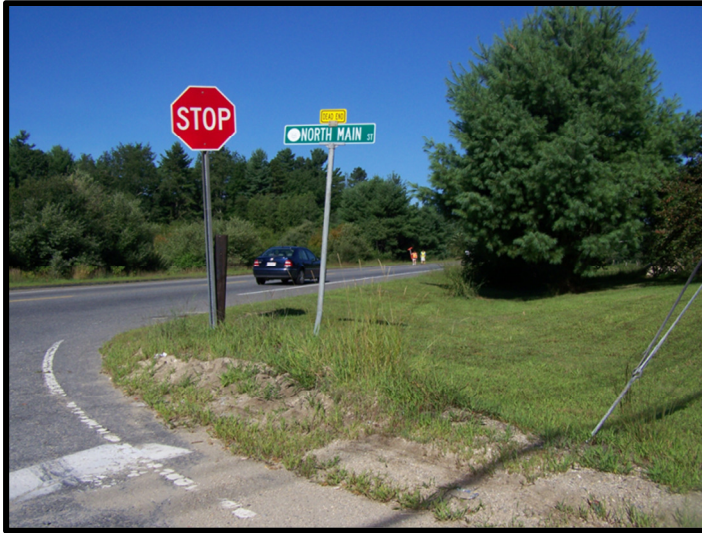
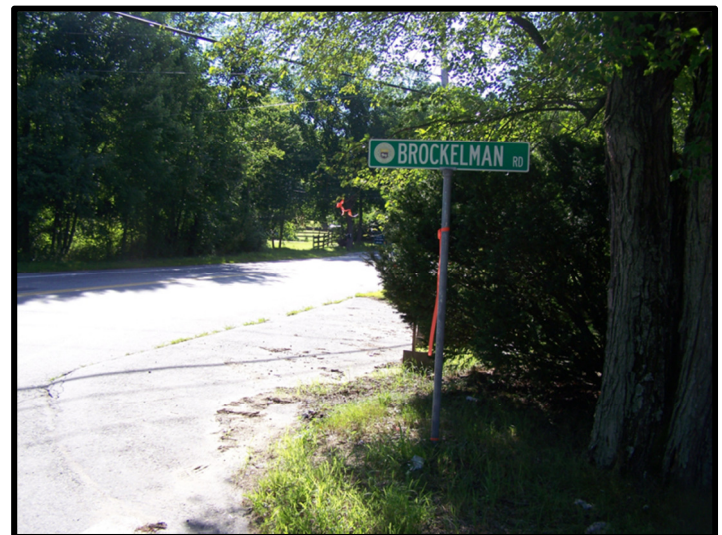
Route 117 at North Main Street

Notes: Bushes and trees on a private property block sight distance. Trimming or removing these obstacles would improve conditions but probably not provide adequate sight distance.

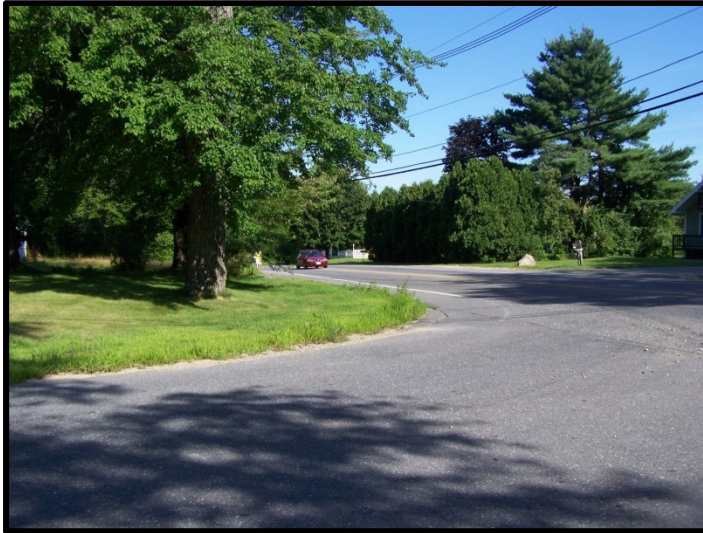
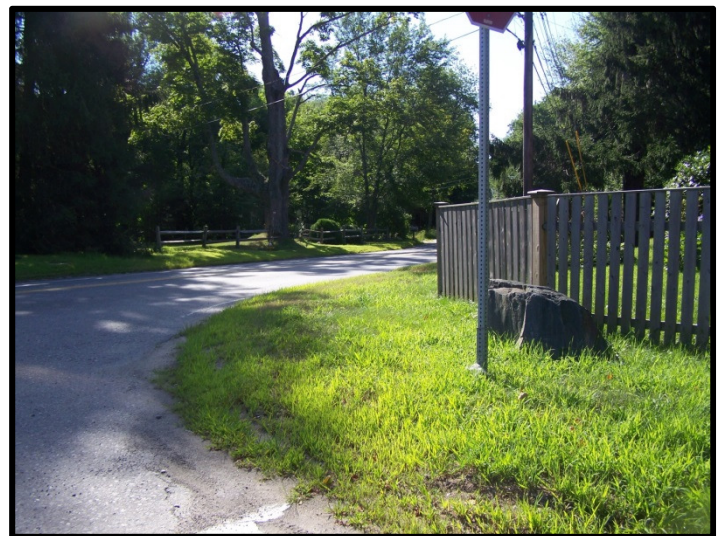
Route 117 at Brockelman Road

Notes: A Private fence and foliage blocks sight distance. Trimming of foliage may slightly increase sight distance however without removal or redesign of private fence significant improvements are unlikely.

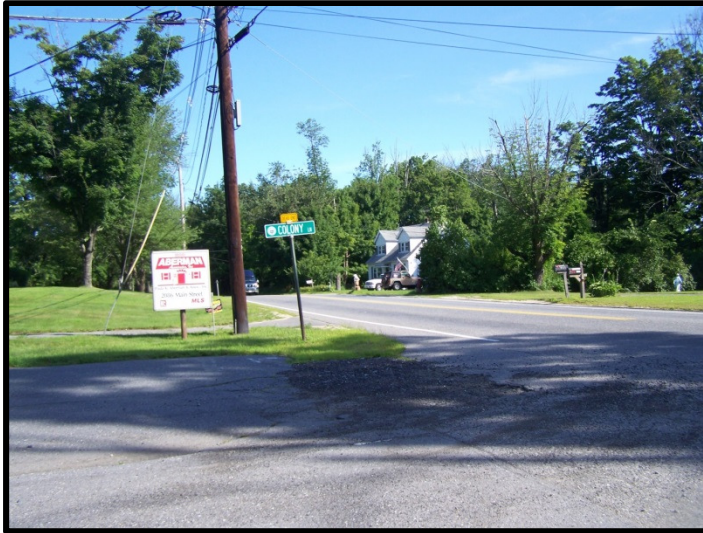
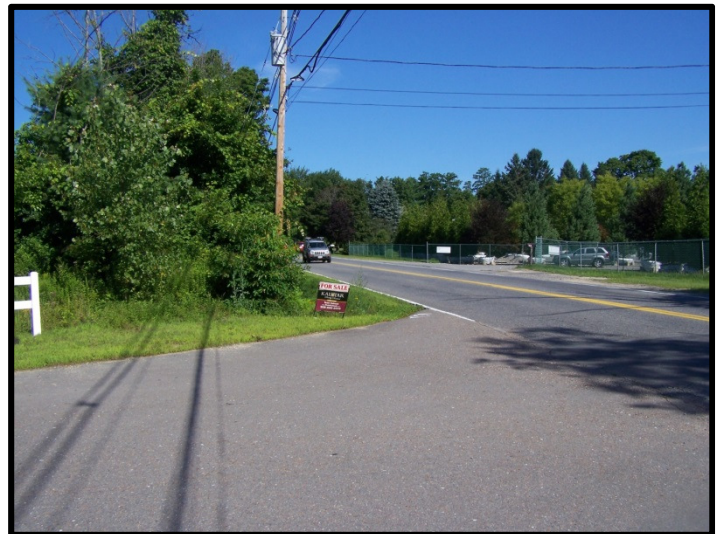
Route 117 at Colony Lane

Notes: Trimming of trees along roadway may greatly increase sight distance.

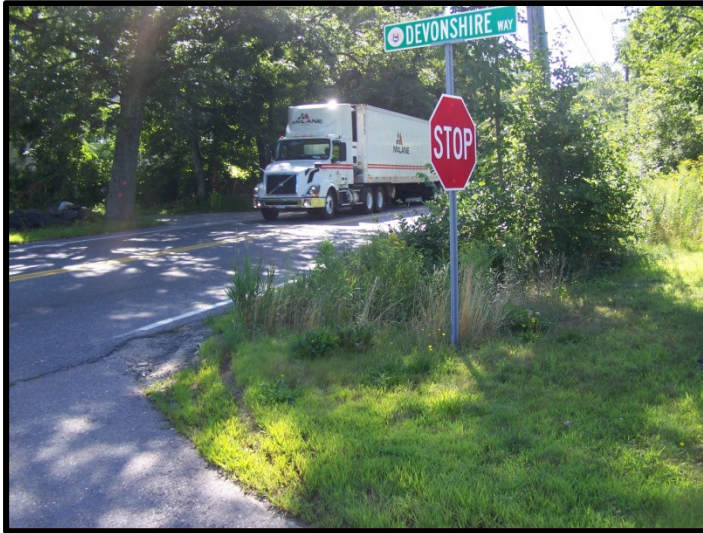
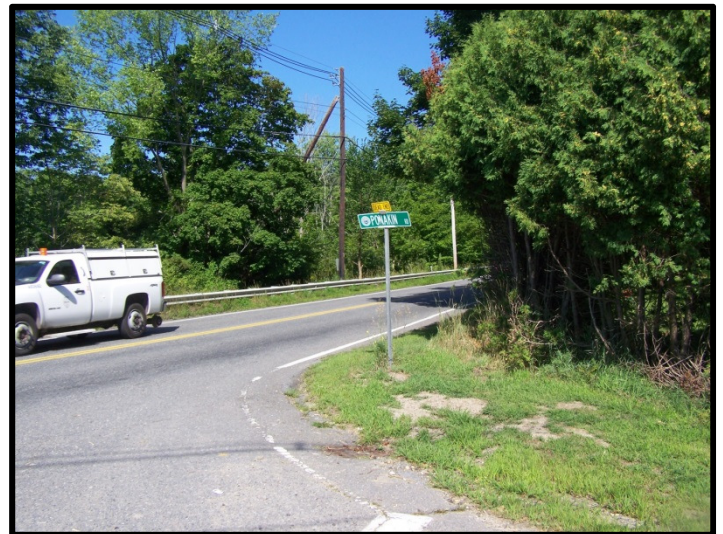
Route 117 at Devonshire Way

Notes: Shrubby and trees on a private property block sight distance. Adequate sight distance could be attained by trimming or removing these obstacles.

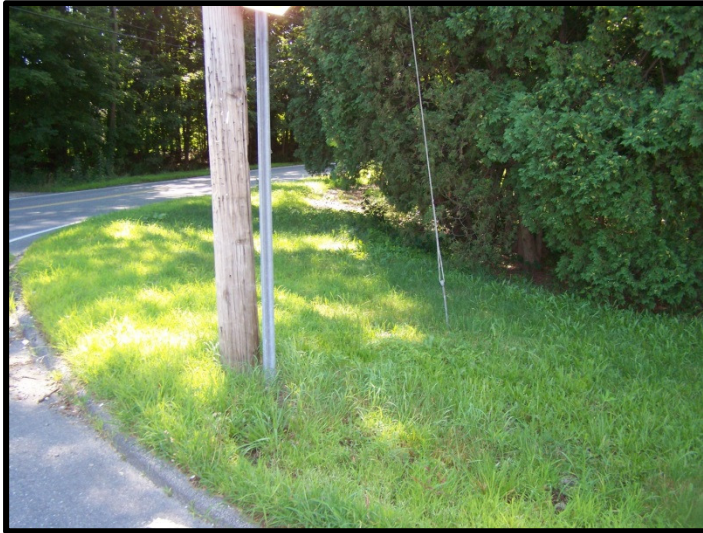
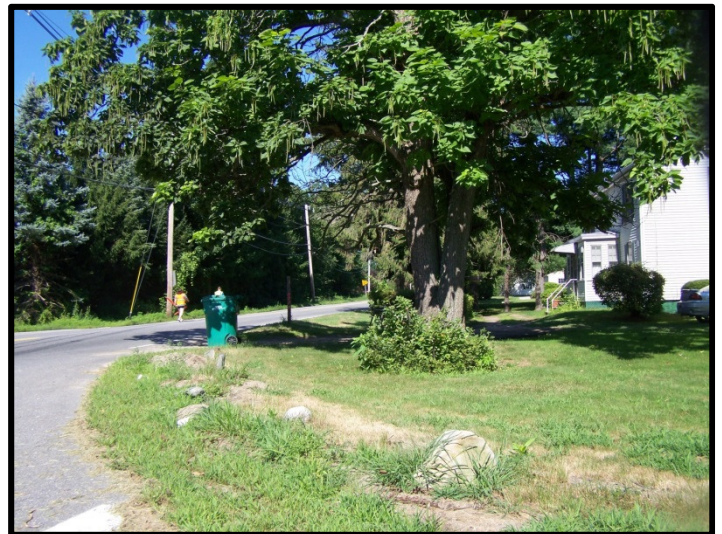
Route 117 at Main Street

Notes: Trimming of private bushes and foliage would improve sight distance.

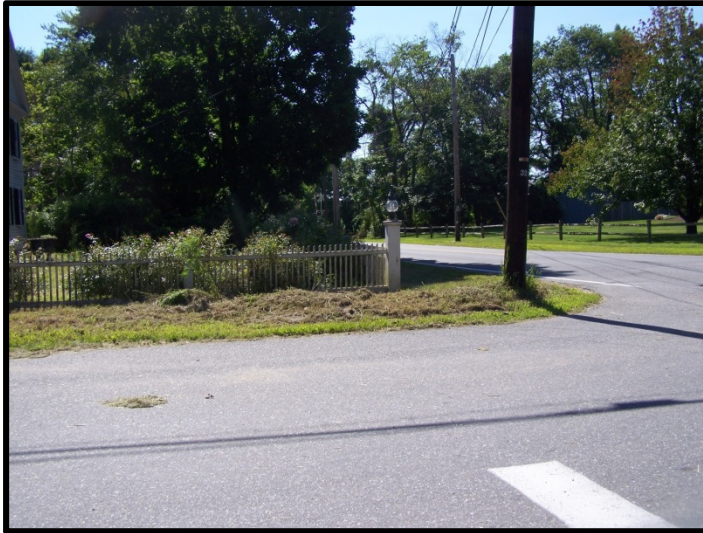
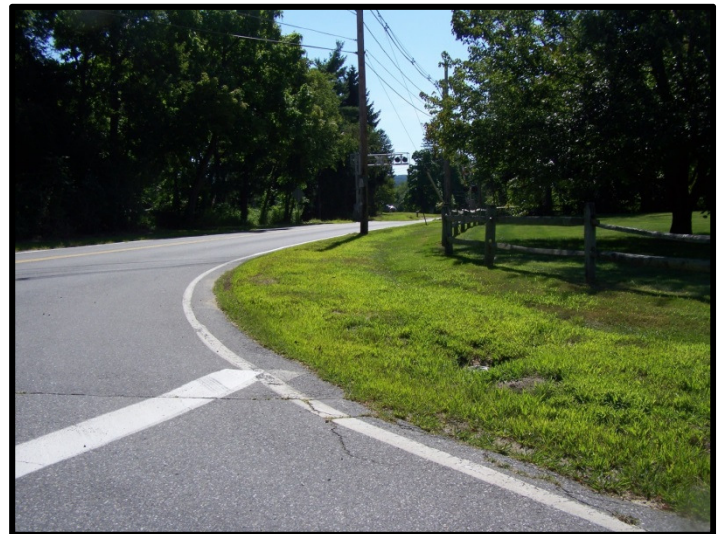
Route 117 at Harvard Road (South)

Notes: Private fence slightly reduces sight distance.

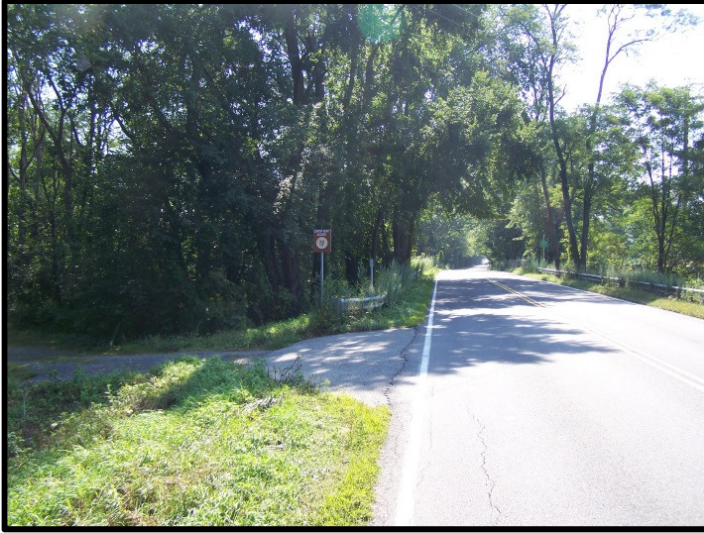
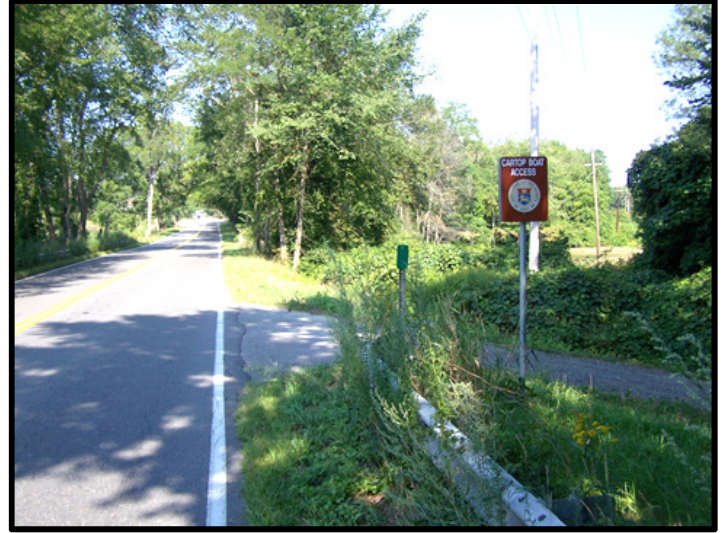
Route 117 at Boat Launch

At the eastern end of the corridor along the Nashua River in the Bolton Flats there are a number of driveways leading to various pullovers on the North side of Route 117. A large farm accounts for a few of these but most notable is a public boat launch and parking area allowing access to the Nashua River. Visibility is a concern at this location due to overgrowth along the roadway; however, hazards are magnified as vehicles possibly towing trailers loaded with canoes are likely to access this launch. Visibility at this site should be increased and additional roadway signage indicating that the launch pull over exists should be installed.

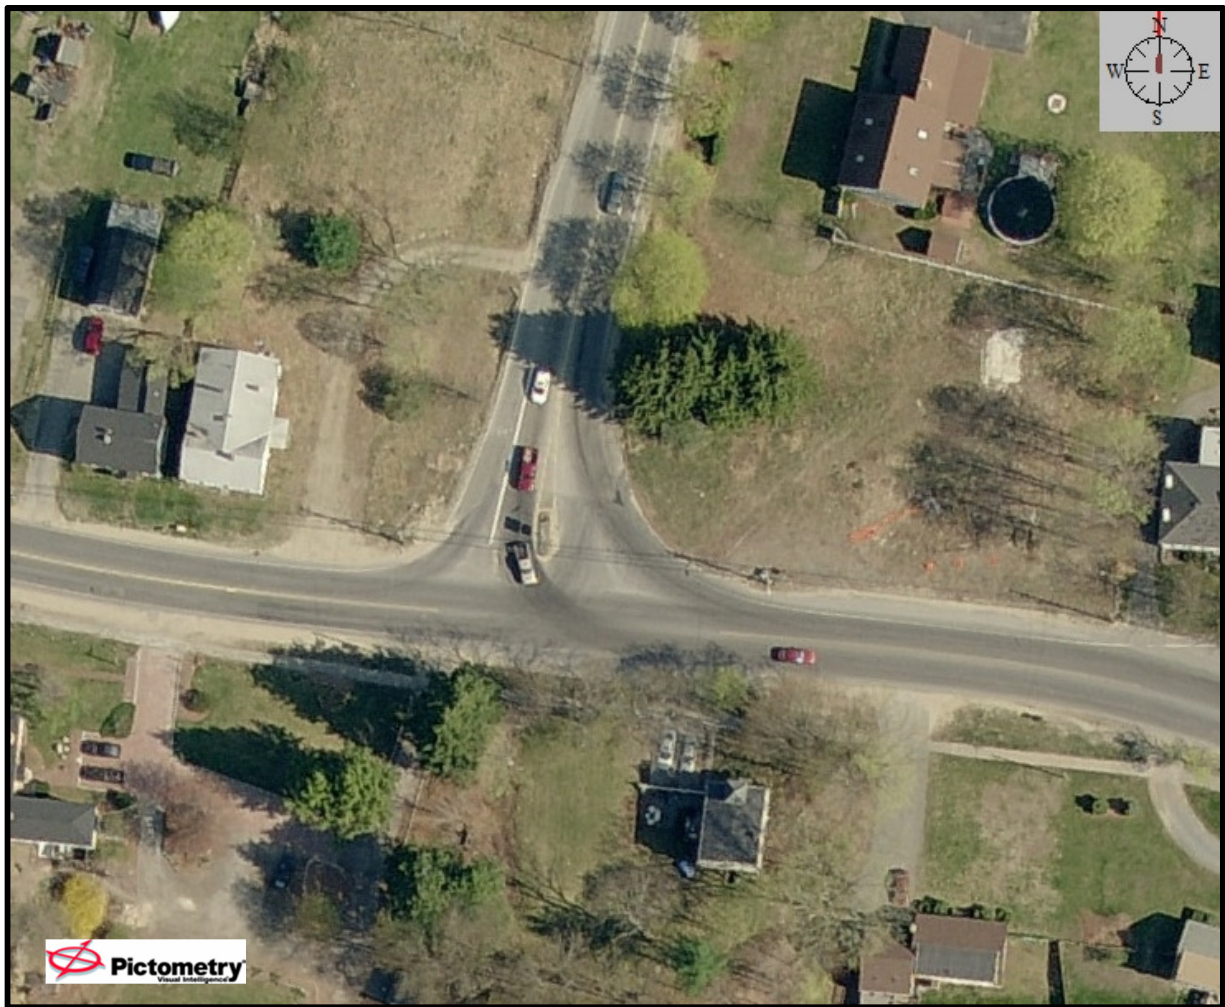
Main St. (Rt. 117) at Lunenburg Rd. (Rt. 70)

Traffic data and HCS results are applied to a *Signal Warrant* program, the program uses the *Manual on Uniform Traffic Control Devices (MUTCD)*, published by the U.S. Department of Transportation, which provides the procedure to test which warrants are satisfied for the intersection being analyzed. Detailed printouts from the data used in the *Signal Warrant* results are in the **Appendix**. The following is a description of the signal warrants applied to the intersection of Route 117 (Main St.) and Route 70 (Lunenburg Rd.).

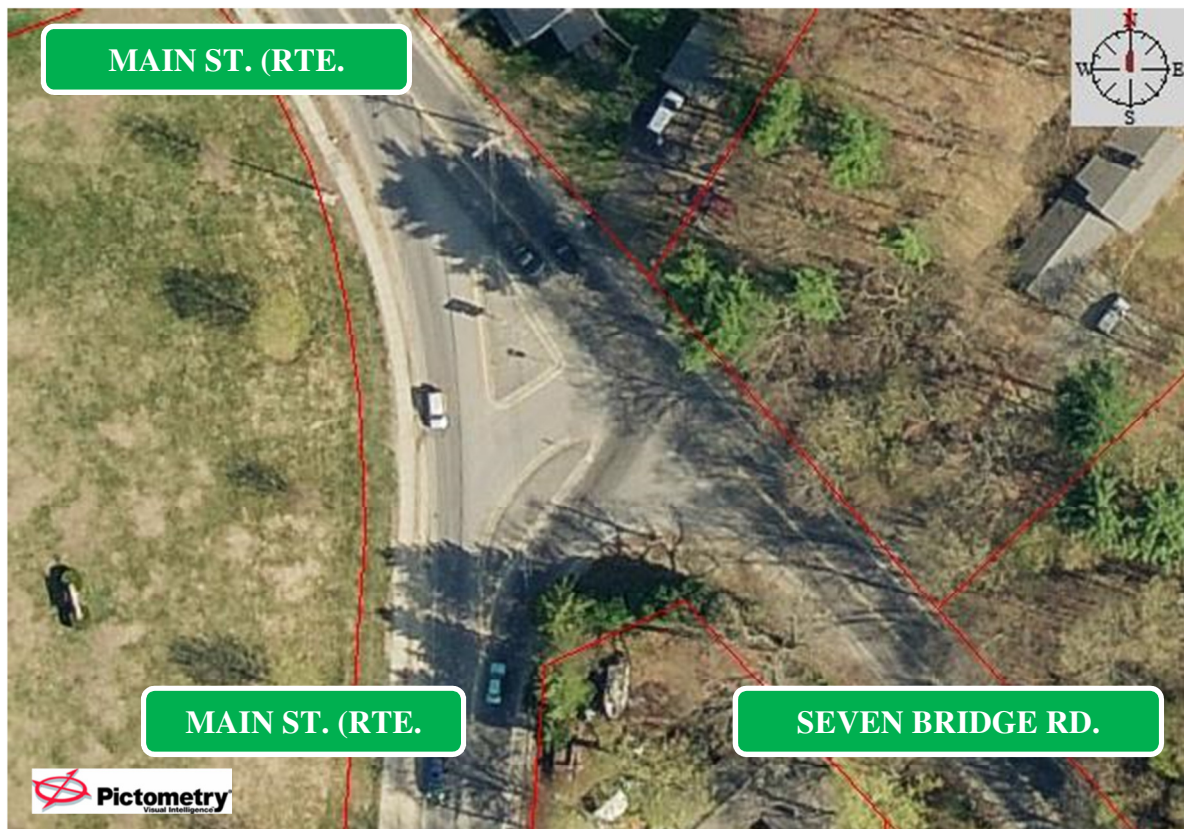
Route 117 at Route 70 (Main St.)

- LOS of minor approach (Main St./Rte. 70)
- Inadequate intersection sight distance
- High crash location

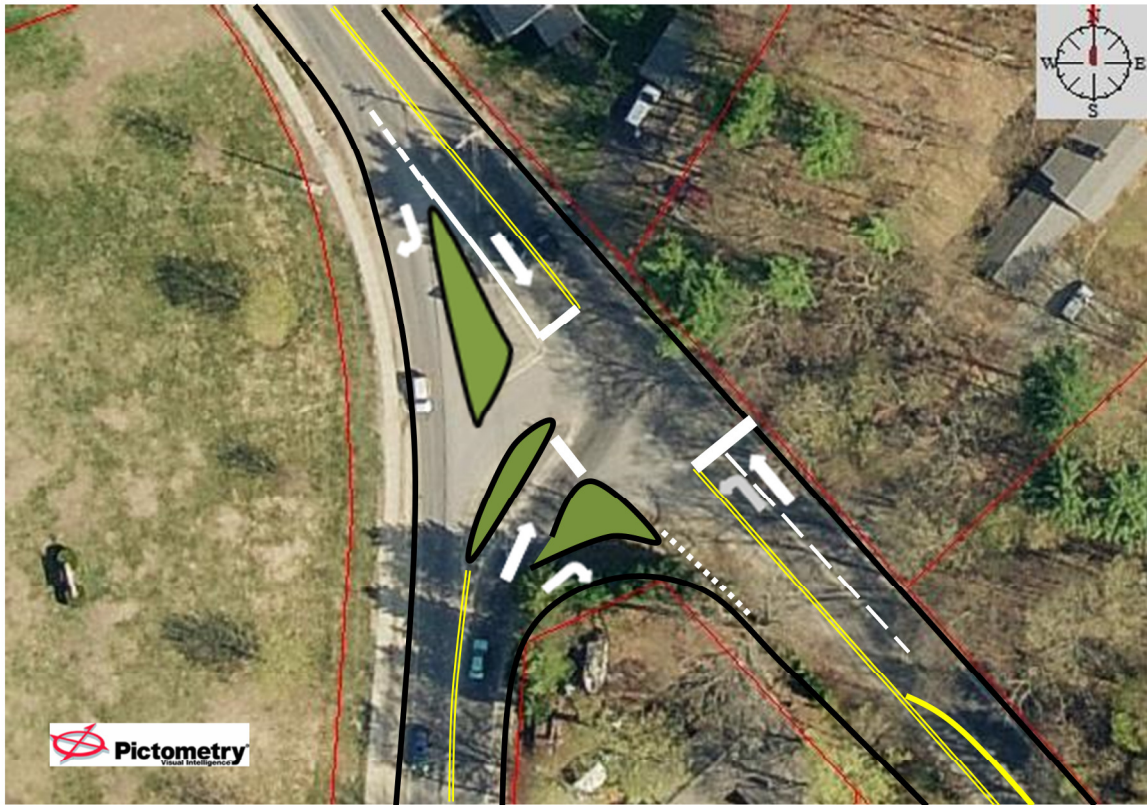
Alternative 1

- Improved LOS for Route 117 Westbound left onto Route 70
- Improved LOS for minor Street approach (Main St/Rte.70)
- Safety Improvement: Increased intersection sight distance

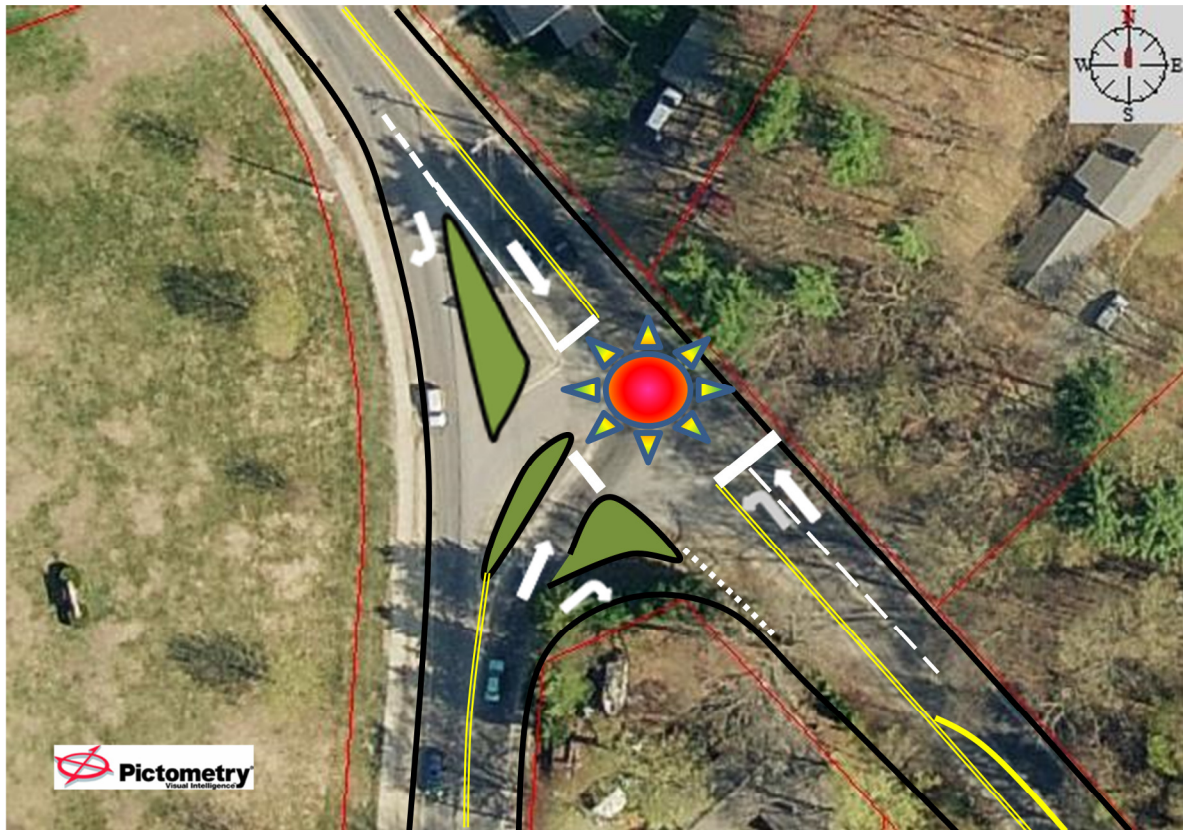
Alternative 2

- Improved LOS for minor street approach
- Slight LOS improvement on Route 117 Westbound
- Safety improvement in resolving sight distance issue may be offset by addition of Traffic Signal (Traffic Signals are known to increase rear end collisions)

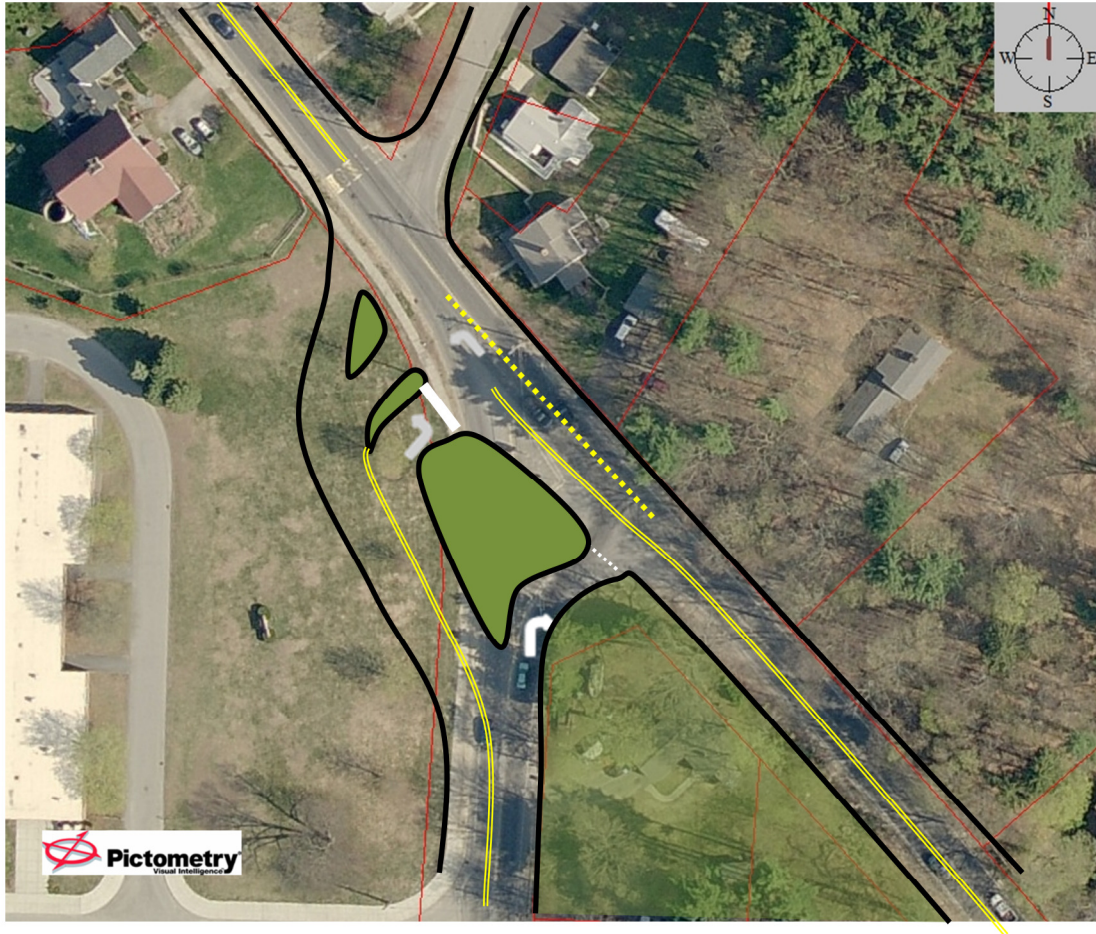
Alternative 3

- Safety improvement: increased intersection sight distance on minor street approach
- LOS improvement on minor approach
- Slight LOS improvement on Route 117 Westbound

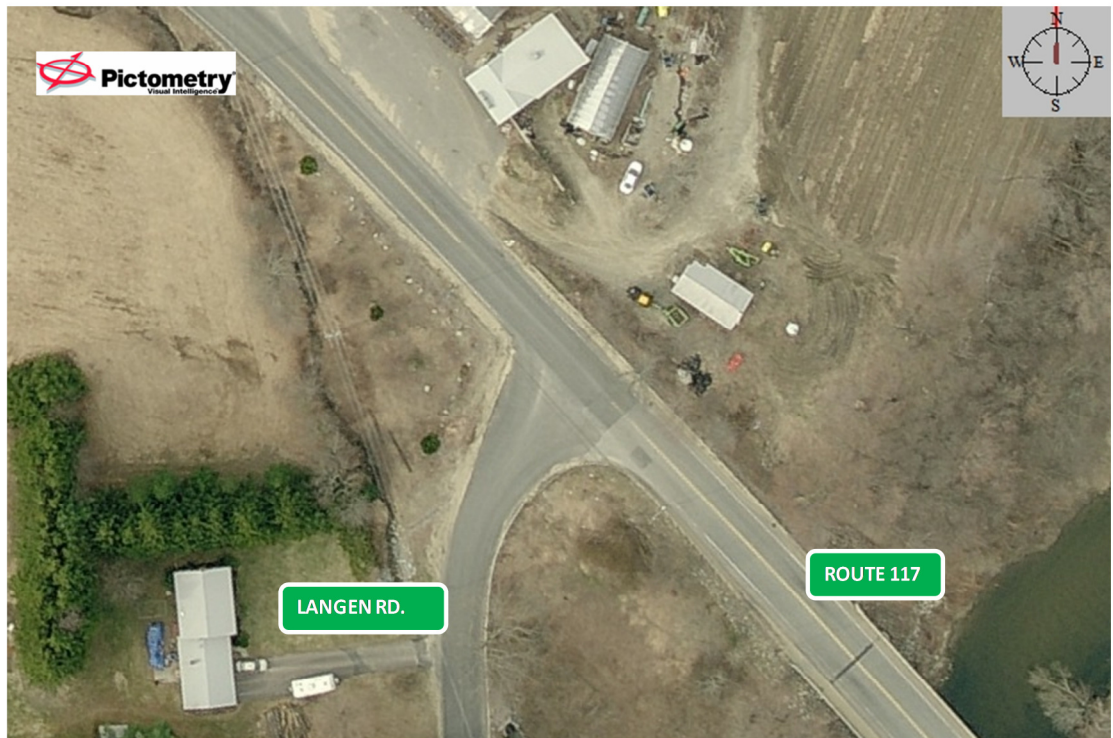
Route 117 at Langen Road

- High crash location (Rear Ends)

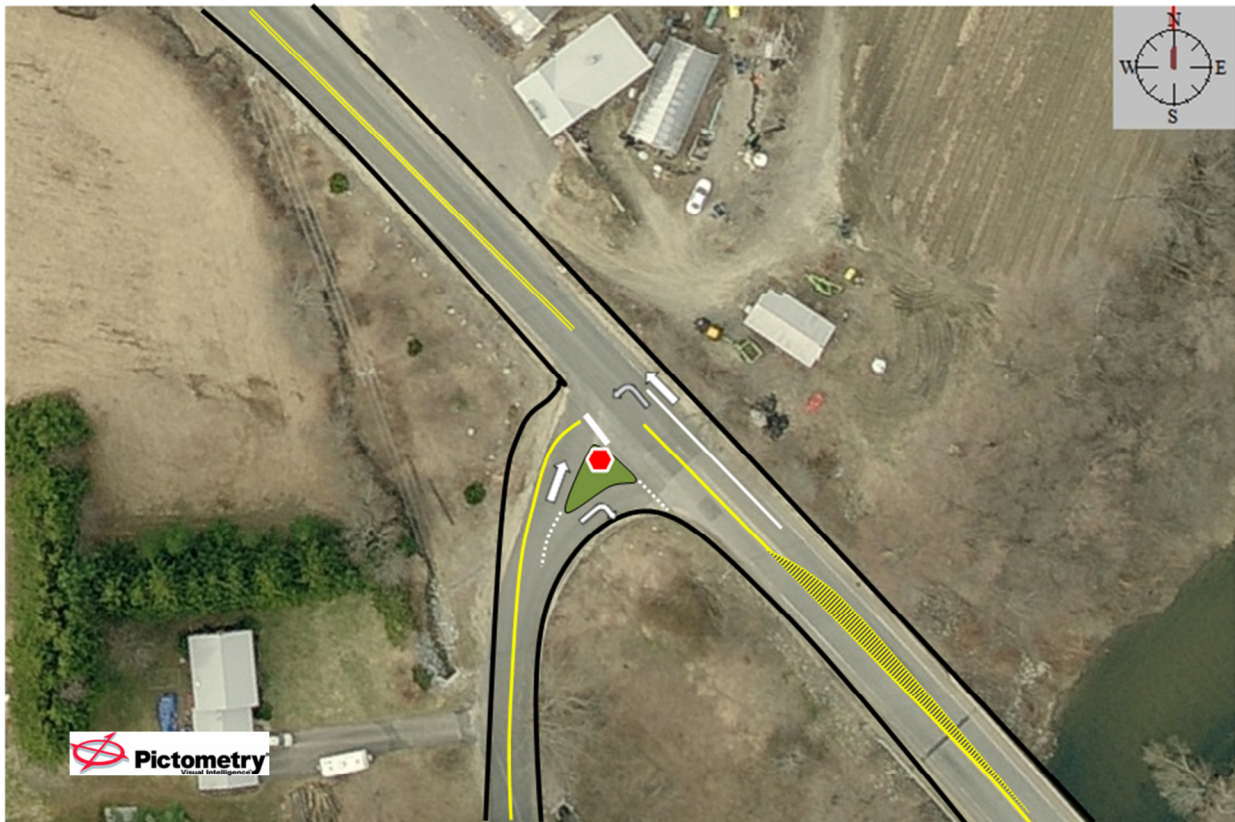
Existing Problems

Alternative

- Add designated Left turn lane on Route 117 Westbound
- Add channelized right turn lane on Langen Road onto Route 117 Eastbound
- Add Traffic Island
- Move minor intersection West and “T” off minor street approach
