**MONTACHUSETT
METROPOLITAN PLANNING ORGANIZATION
(MMPO)**

**Sterling – Princeton - Westminster
Route 140 Corridor Profile**

Sterling Segment

December 2010

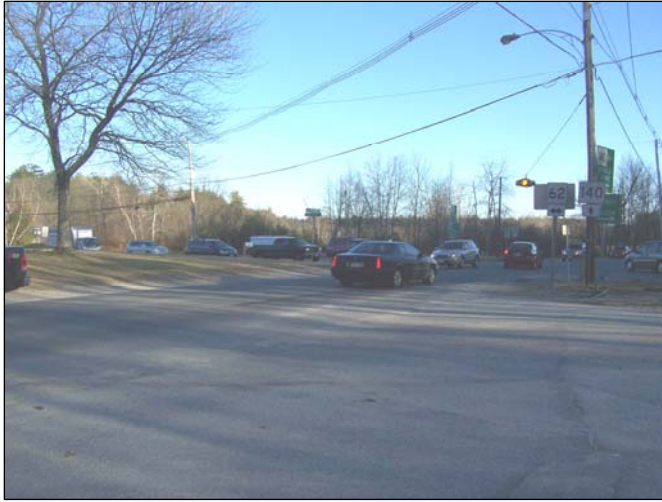
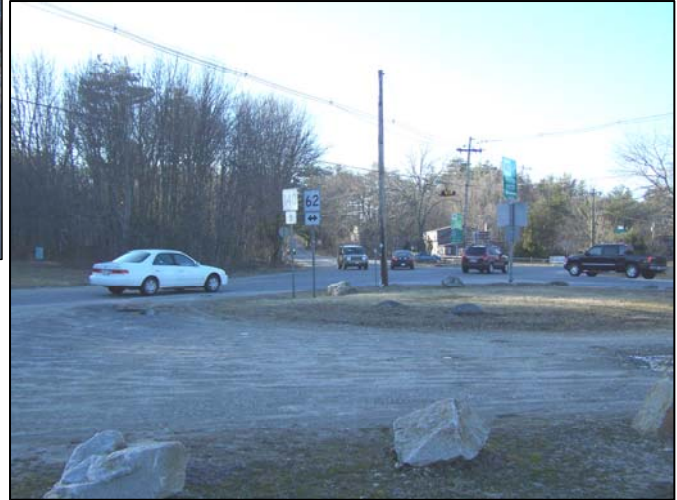
4.5 Crash Analysis of the Route 62 Intersection

- The crash rate for this intersection equals **1.36** which is well **ABOVE** the District 3 average crash rate of **0.69** for unsignalized intersections. Since this location has a crash rate above the average crash rate countermeasures need to be developed to address the safety issues to effectively reduce the crash rate. See Technical Appendix for full crash rate analysis.

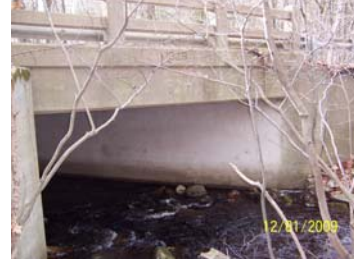
East Side

| Location # | Culvert Type/Material | Observed Condition | Size (Diameter) | Approx. Length | Field Observations, Comments |
|---|---|---|---|---|--|
| 1 | Concrete box | Good/ Some wear on bridge rail/ Some visible rebar inside | 17' | 26' | Unobstructed, free flowing; Height is 8' |

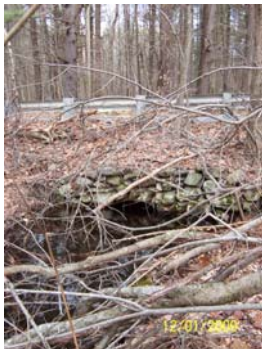
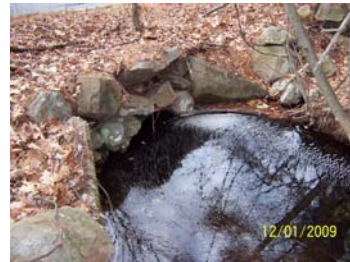
| Location # | Culvert Type/Material | Observed Condition | Size (Diameter) | Approx. Length | Field Observations, Comments |
|---|---|---|---|---|--|
| 2 | Corrugated pipe | Good | 3' - 4' | 25' | 1/4 of pipe visible; Tree branches near west side; Slow moving; Debris in stream; Might be clogged |

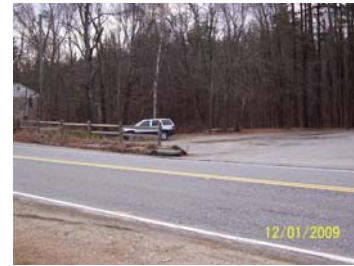
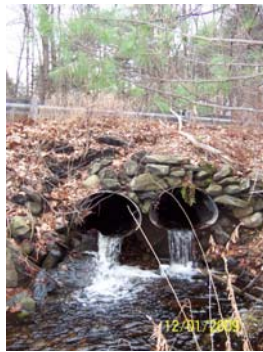
*Looking Across from East to West*

| <i>Location #</i> | <i>Culvert Type/Material</i> | <i>Observed Condition</i> | <i>Size (Diameter)</i> | <i>Approx. Length</i> | <i>Field Observations, Comments</i> |
|---|---|---|---|---|---|
| 3 | Segments of Corrugated Pipe | Poor | 3' in East, 3.5' in West | 150' + | Lots of wood debris on West side; East side corrosion; Goes through private property on East side |

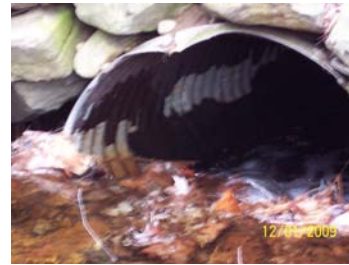
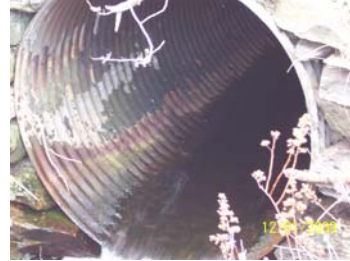
| <i>Location #</i> | <i>Culvert Type/Material</i> | <i>Observed Condition</i> | <i>Size (Diameter)</i> | <i>Approx. Length</i> | <i>Field Observations, Comments</i> |
|---|---|---|---|---|---|
| 4 | 2 Corrugated pipes | Fair | 3.5' - 2.5' | 26' | Double pipes are both oval shape; Some debris and sediment on West side |

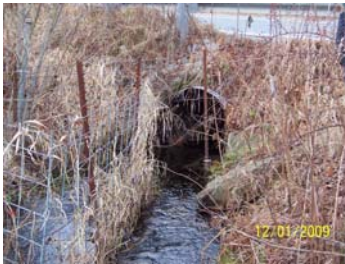
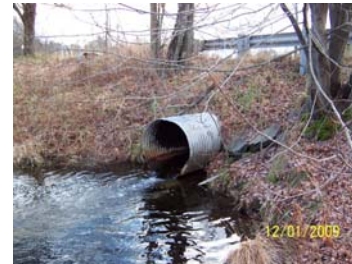
| <i>Location #</i> | <i>Culvert Type/Material</i> | <i>Observed Condition</i> | <i>Size (Diameter)</i> | <i>Approx. Length</i> | <i>Field Observations, Comments</i> |
|---|---|---|---|---|---|
| 5 | Corrugated pipe | Poor | 4' | 26' | Free flow; Bottom of pipe rusted throughout |

| <i>Location #</i> | <i>Culvert Type/Material</i> | <i>Observed Condition</i> | <i>Size (Diameter)</i> | <i>Approx. Length</i> | <i>Field Observations, Comments</i> |
|---|---|---|---|---|---|
| 6 | Corrugated pipe | Good | 3' | 27' | Some debris in stream on West side |

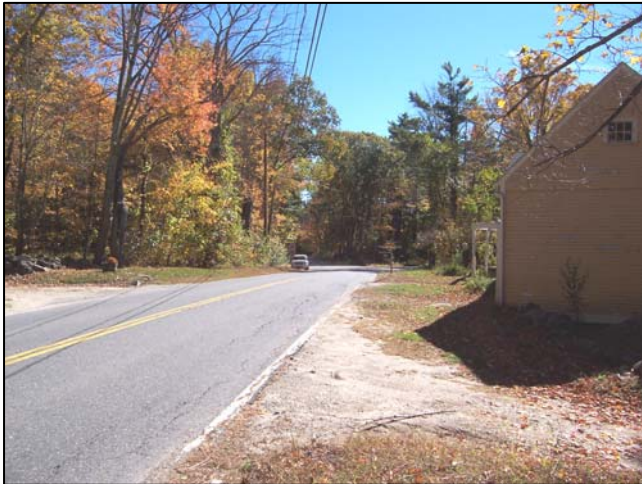
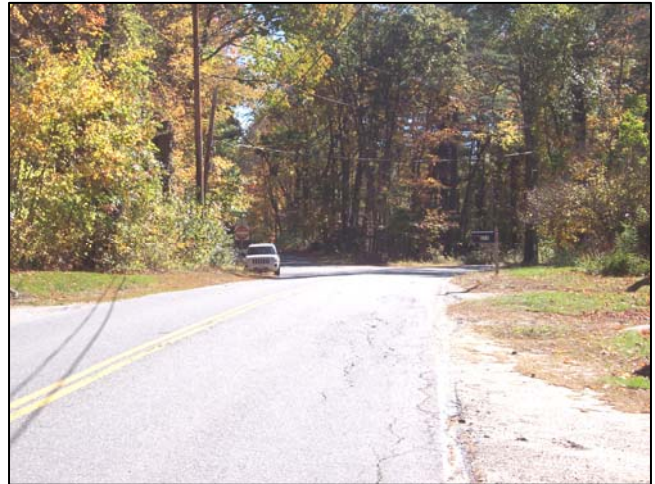
Photos: Geometric & Other Issues

- Although stopping is adequate, minor vertical and horizontal curves, vegetation, and the location of Beaman Road at the midpoint of the horizontal curve combine to make it difficult for south bound vehicles to discern the path of Route 140.
- There is a tendency for south bound vehicles to depart their travel lane and travel into the opposing north bound lane.
- Vegetation hinders clear view of the **DO NOT ENTER** signs on Beaman Road.

Views from North Bound Approach (looking south)

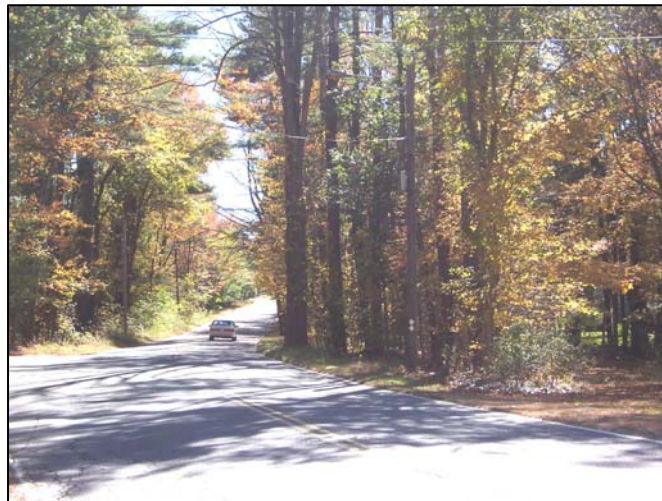
Vegetation Opposite of Beaman Road on Horizontal Curve that Inhibits the Ability of a Driver to View the Roadway Ahead.

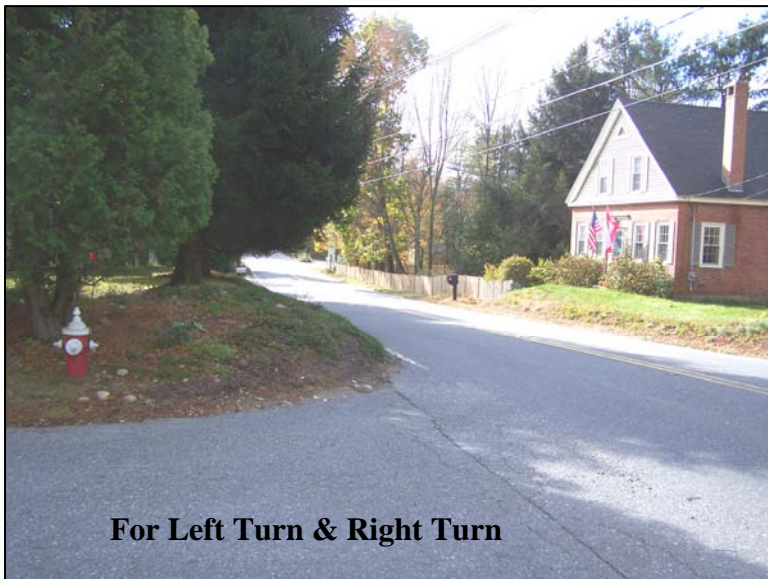
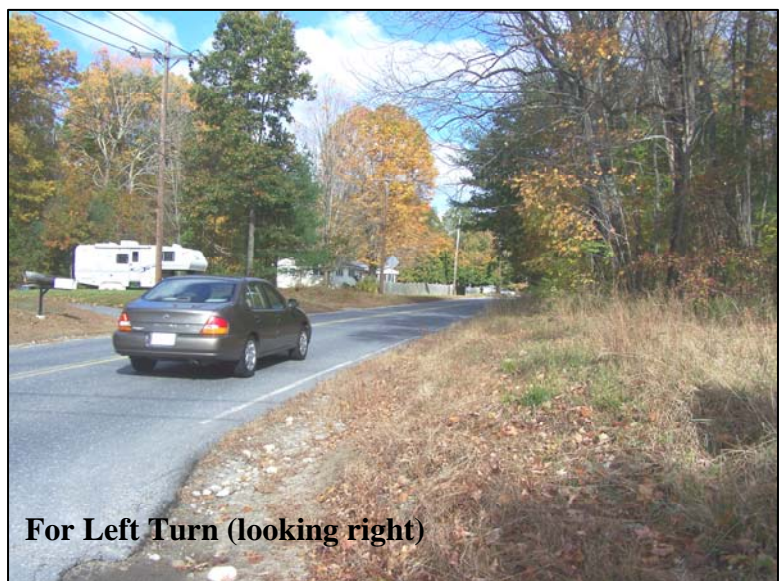
Photos*: Not Adequate Sight Distance Result

- **Int. # 2: North Oakdale Cutoff: Intersection SD**

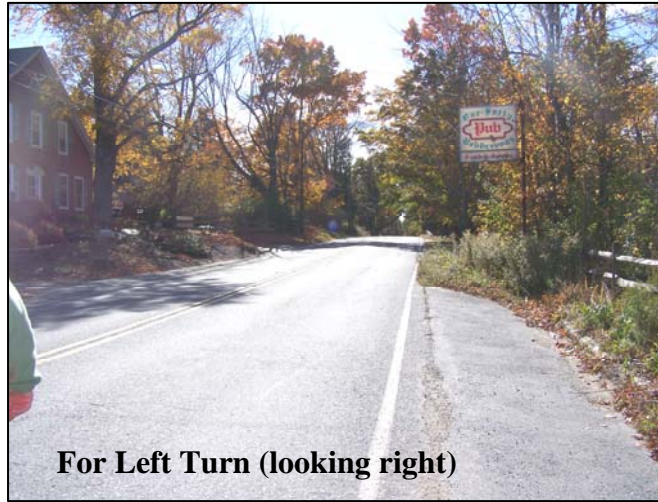
Photo*: Adequate But Close Sight Distance Result

- Vertical curve to the south will affect left turn movement at slightly higher travel speeds.

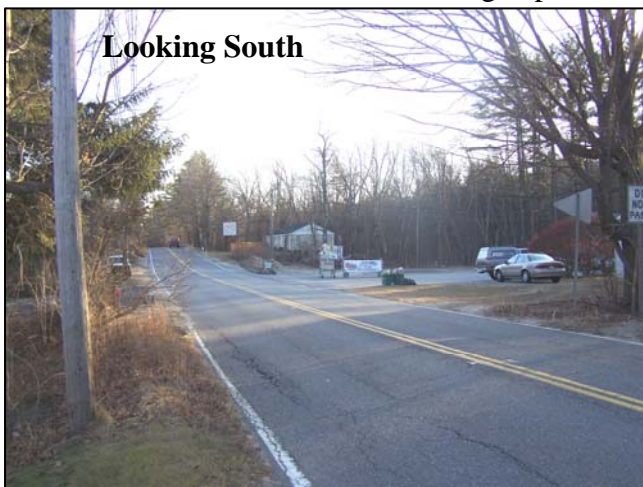
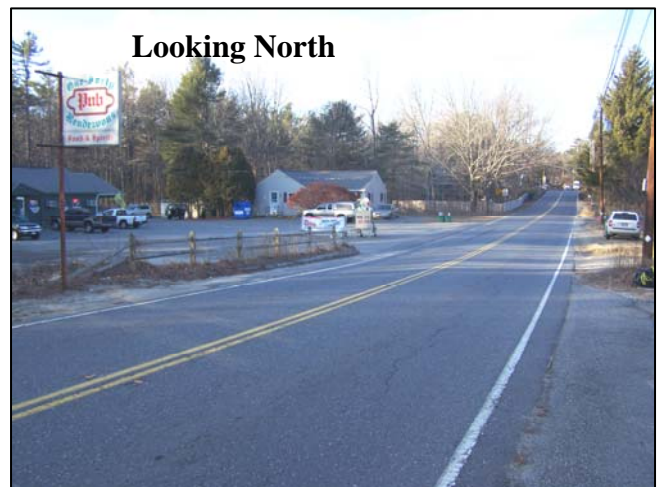
On street parking occurs on both sides of Route 140 usually after nightfall (daytime photos below). Safety is comprised due to:

- The road width prevents adequate on street parking accommodation.
- The vertical curve to the south prevents north bound drivers from being aware of parked vehicles. The response time a driver has to stop or slow down is most likely insufficient for stopping or maneuvering safely.
- After sunset the roadway is dark due to inadequate lighting.
- No advanced warning is provided.

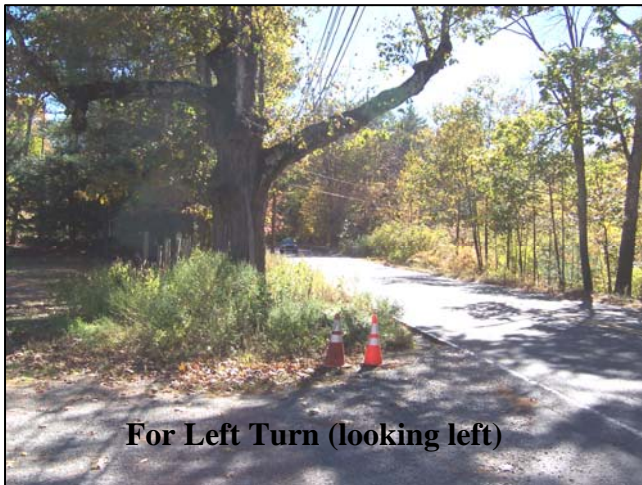
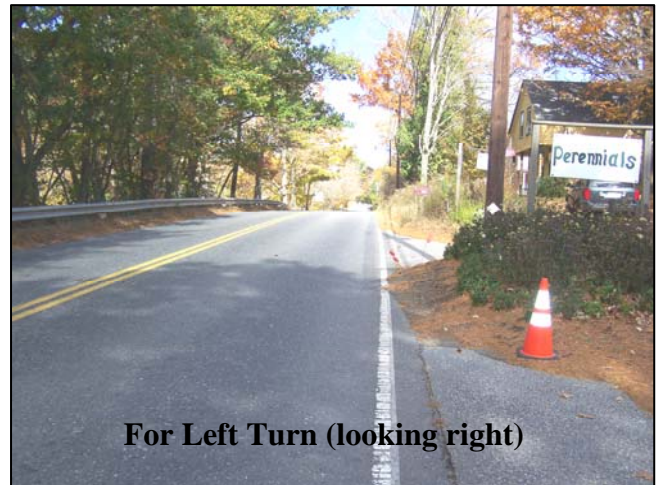
Photo*: Not Adequate / Adequate But Close Sight Distance Results

- Vertical curve, vegetation, and pole to the north affect left turn movements.
- Vegetation and pole to the south will affect left movement at somewhat higher travel speeds.
- Vertical curve to the north will affect south bound stopping at slightly higher travel speeds.

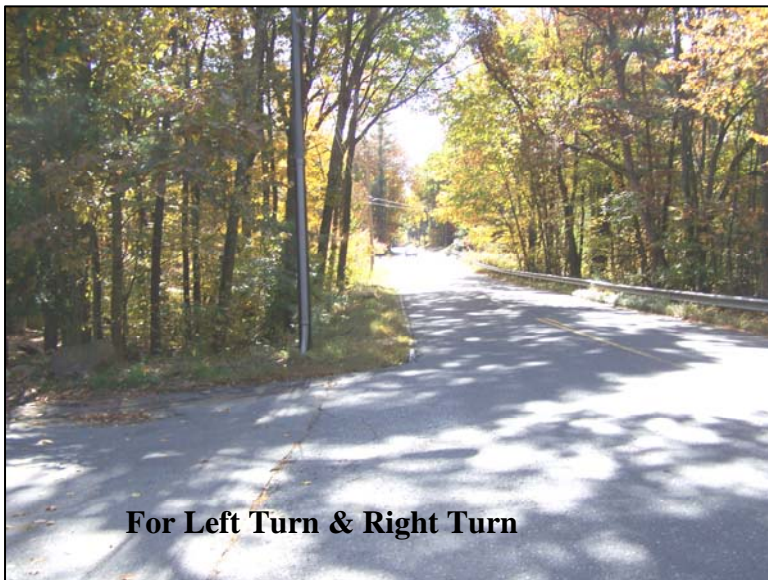
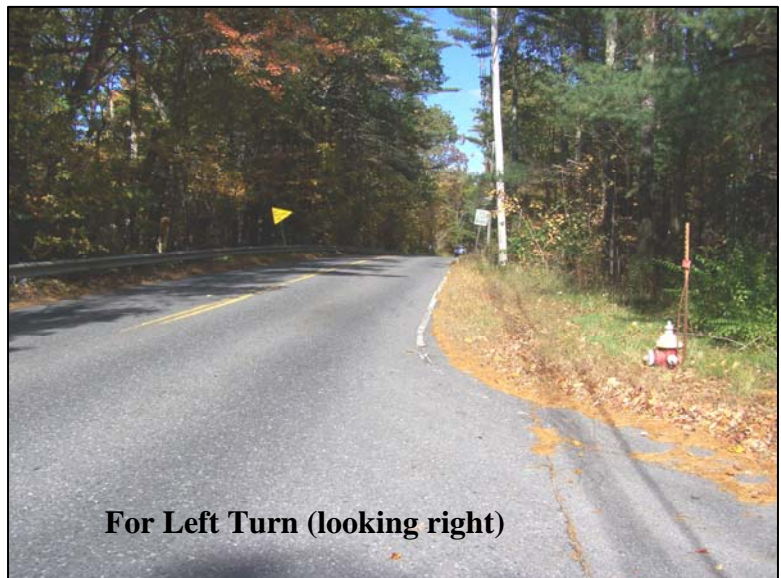
Photo*: Not Adequate / Adequate But Close Sight Distance Results

- **Int. # 3: Still River Road: Intersection SD**

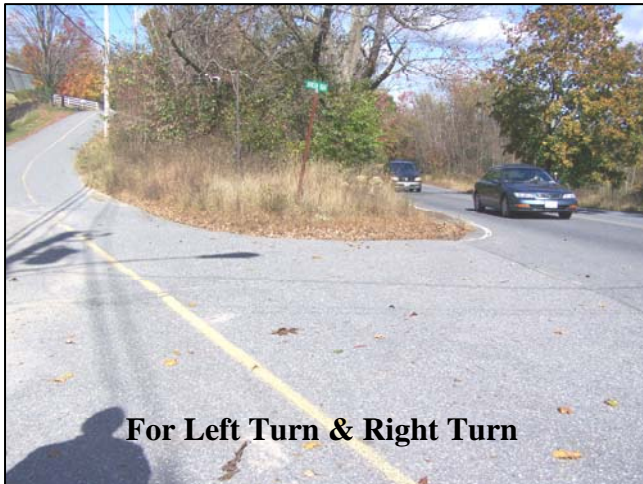
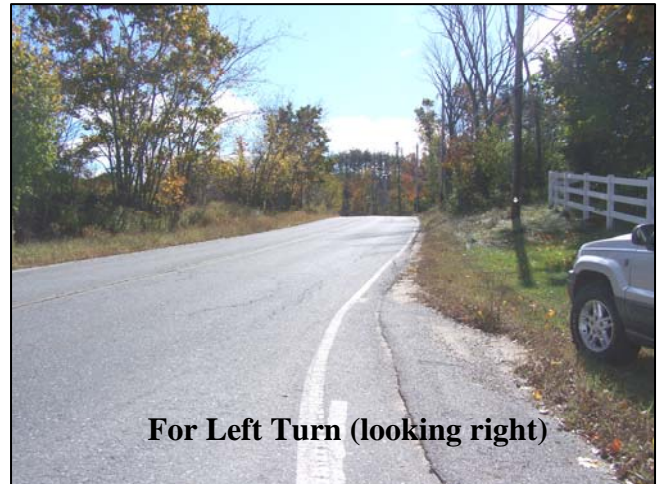
Photo*: Not Adequate / Adequate But Close Sight Distance Results

- Skewed intersection and vegetation on the north side of the intersection affect both STOP controlled movements.
- Vertical curve, horizontal curve, vegetation to the south will affect left turn movements at slightly higher travel speeds.
- Vertical curve, horizontal curve, vegetation to the south will affect north bound stopping at slightly higher travel speeds.

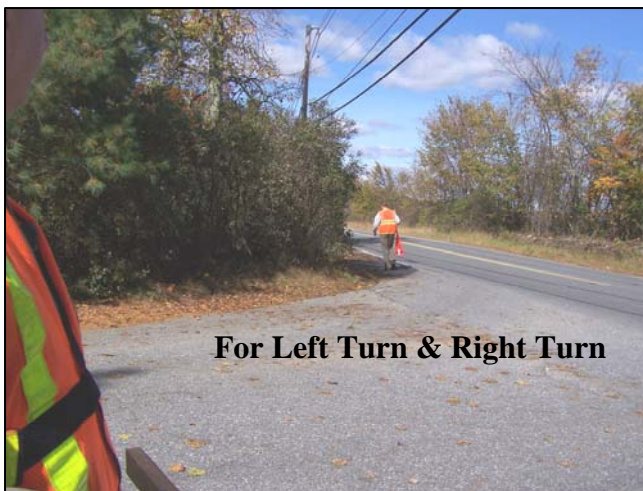
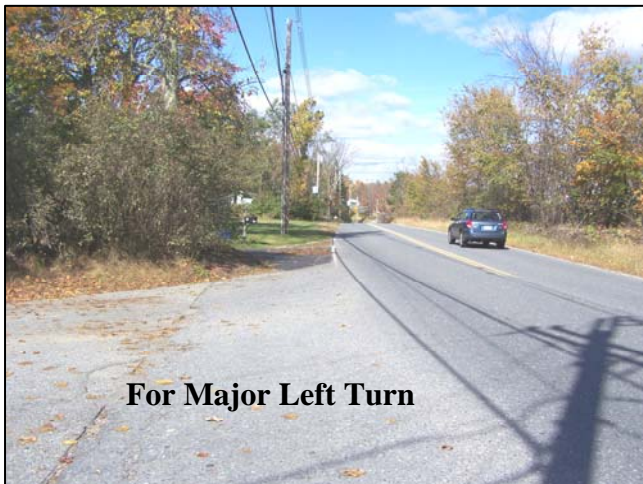
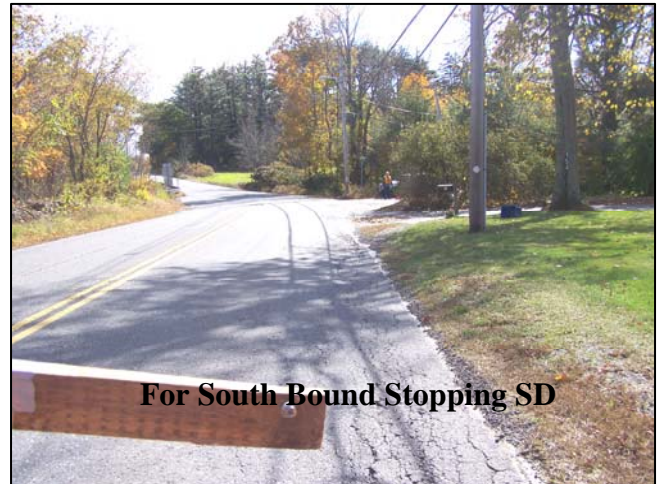
Photo*: Not Adequate / Adequate But Close Sight Distance Results

- Vegetation on the north side of the intersection affect both STOP controlled movements.
- Vegetation and pole on the south side of the intersection will affect left turn movements at slightly higher travel speeds.
- Vertical curve to the north will affect left turn movement from major road at slightly higher travel speeds.
- Vertical curve to the north will affect south bound stopping at slightly higher travel speeds.

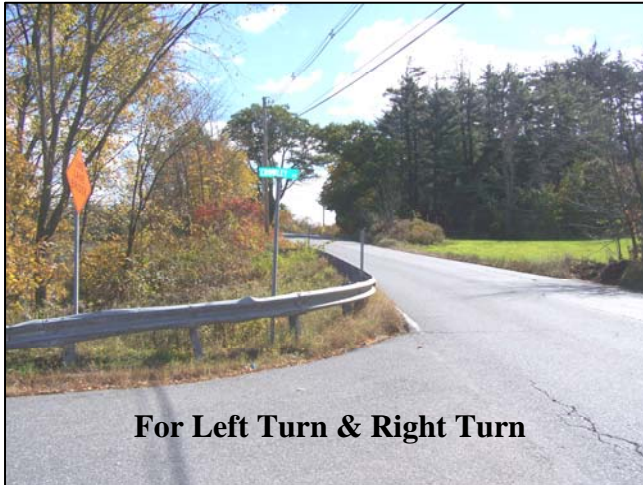
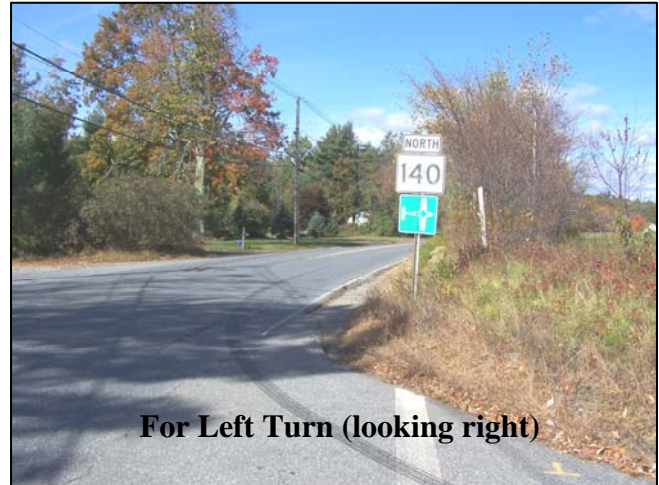
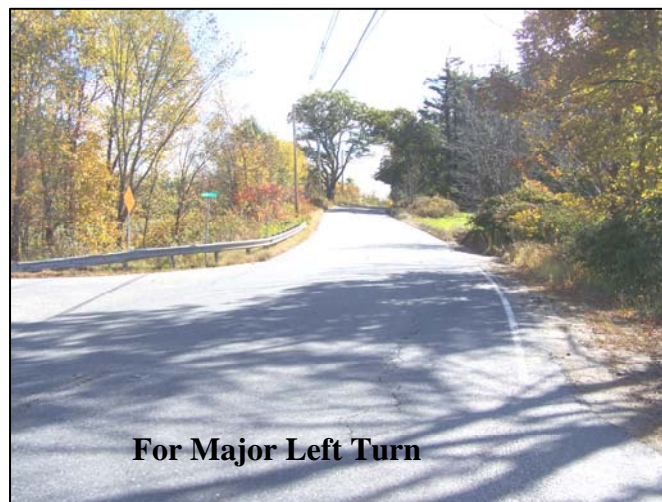
Photo*: Not Adequate / Adequate But Close Sight Distance Results

NOTE: Left turns are not permitted at this intersection. A **NO LEFT TURN** sign is posted opposite the approach.

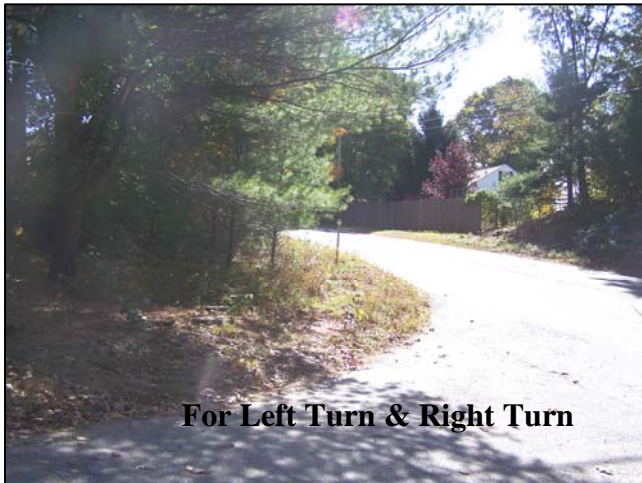
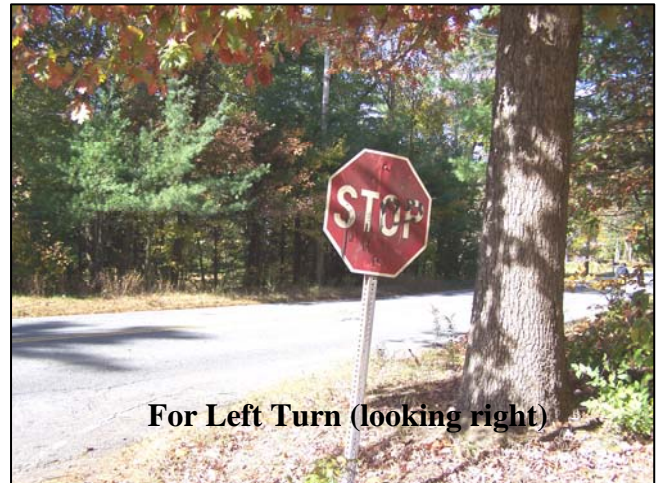
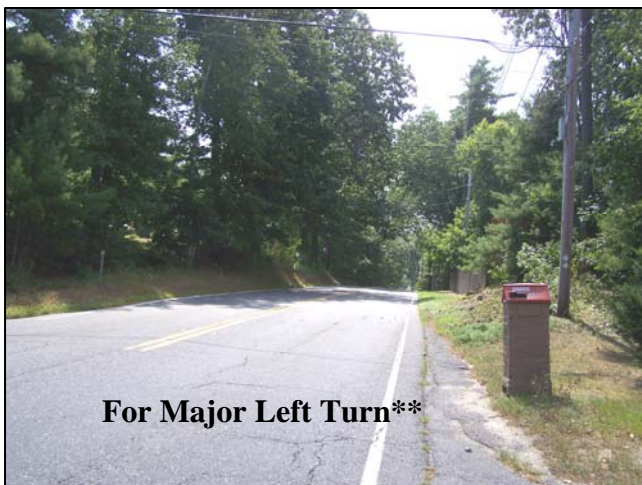
Photos*: Not Adequate / Adequate But Close Sight Distance Result

- Vertical curve, sideslope, vegetation on south side of intersection, and sign, vegetation on north side of intersection affect both STOP controlled movements.
- Vertical curve affects left turn movements from major road.
- Vertical curve, sideslope, vegetation on east side of intersection affect north bound stopping.

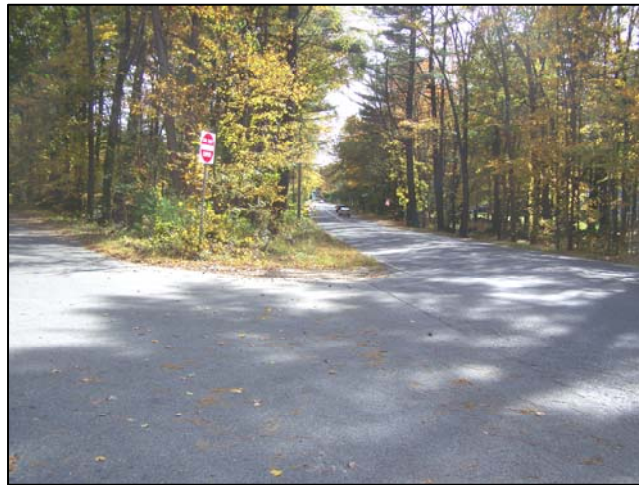
- **STOP** signs are not posted on the minor approach of the Still River Road, Burpee Road, Fox Run Road, and Merrill Road intersections.
- **ONE WAY** signs are not posted with the existing **DO NOT ENTER** signs on the minor approach of the Beaman Road intersection (photo below).

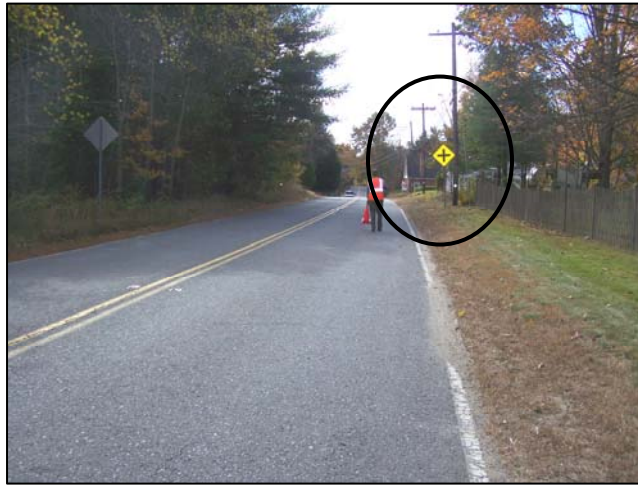
- **Intersection Ahead Signs:** The North Oakdale Cutoff (photo below), Route 62, and Clemence Avenue intersections are the only intersections with these signs. The signs for the North Oakdale Cutoff and Route 62 intersections are located north of the intersections for vehicles heading south. The sign for the Clemence Avenue intersection is located south of the intersection for vehicles heading north.

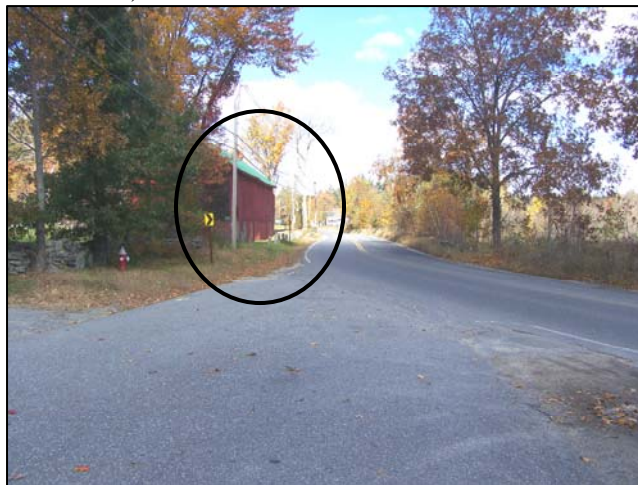
- **Chevron Signs:** Only two are located on the curve just north of Johnson Road (north) (photo below).

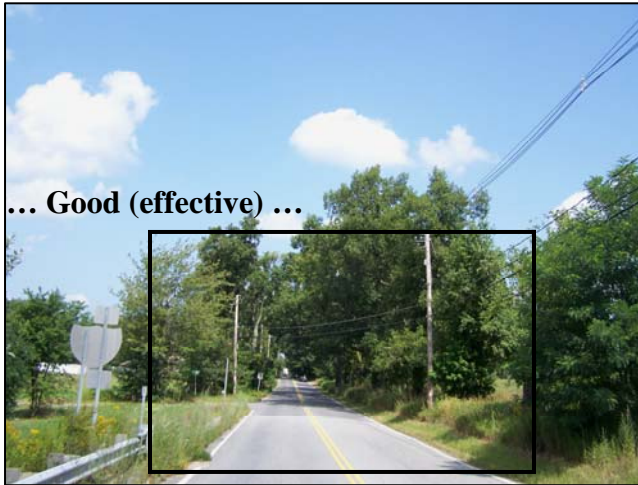
North of Legg/Dana Hill Road

- **As of December 10, 2010, Pavement Markings are not Retroreflectorized & Effectiveness Ranges from ...**

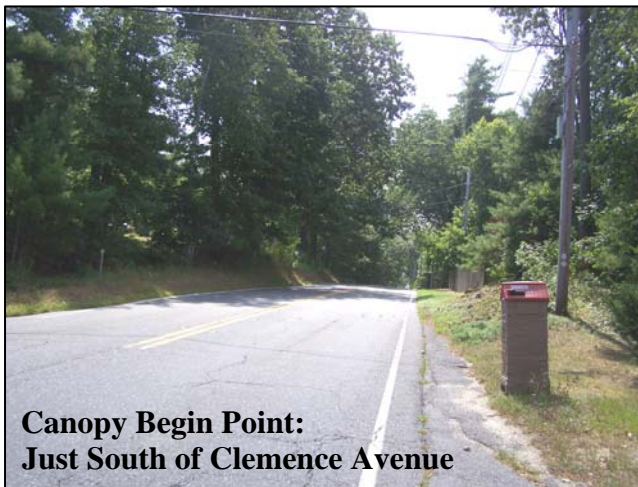
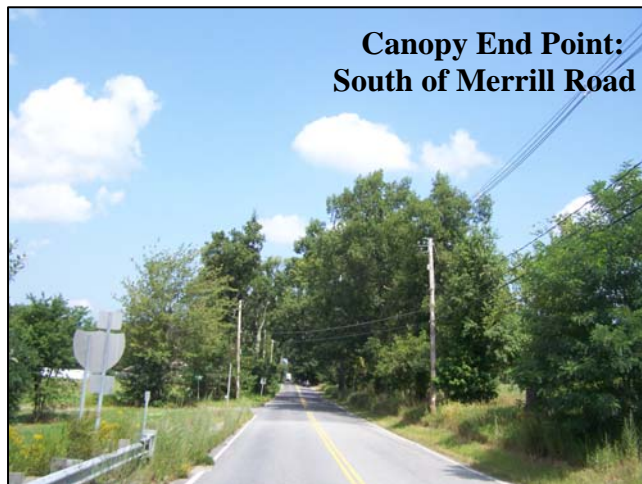
Photos*: Clemence to Merrill Road Tree Canopy

| Tree Canopy Name | Begins | Ends |
|---|---|--|
| Clemence to Merrill Road | 43' North of Clemence Road | 98' South of Merrill Road |

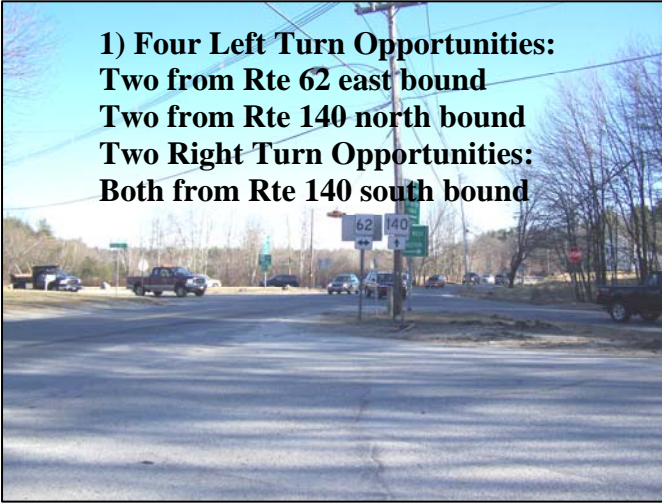
- 1) Four Left Turn Opportunities:
Two from Rte 62 east bound
Two from Rte 140 north bound
Two Right Turn Opportunities:
Both from Rte 140 south bound**

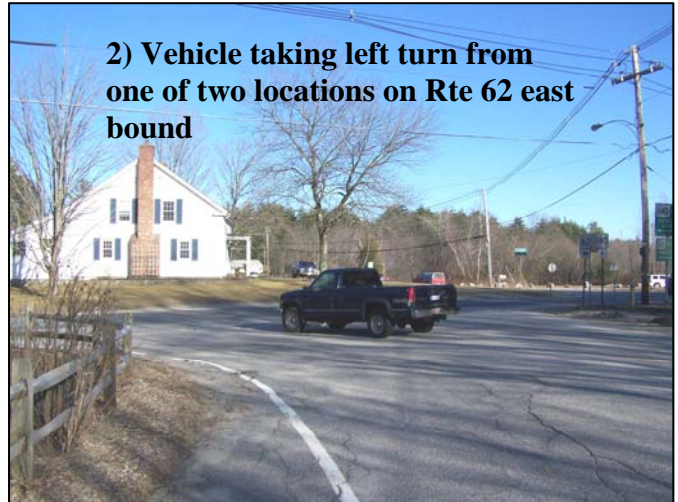
- 2) Vehicle taking left turn from
one of two locations on Rte 62 east
bound**

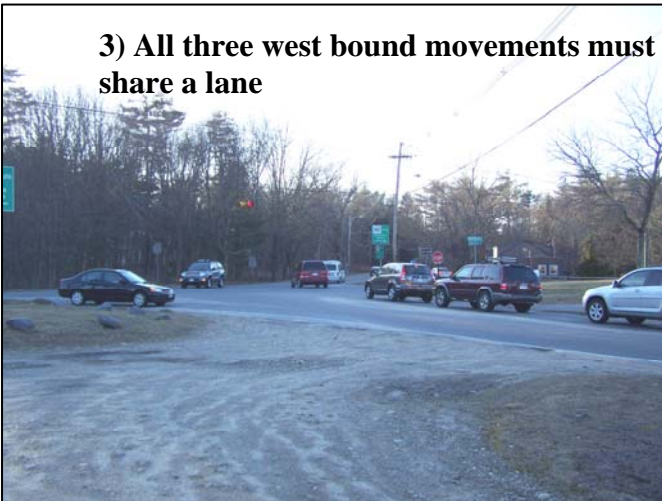
- 3) All three west bound movements must
share a lane**

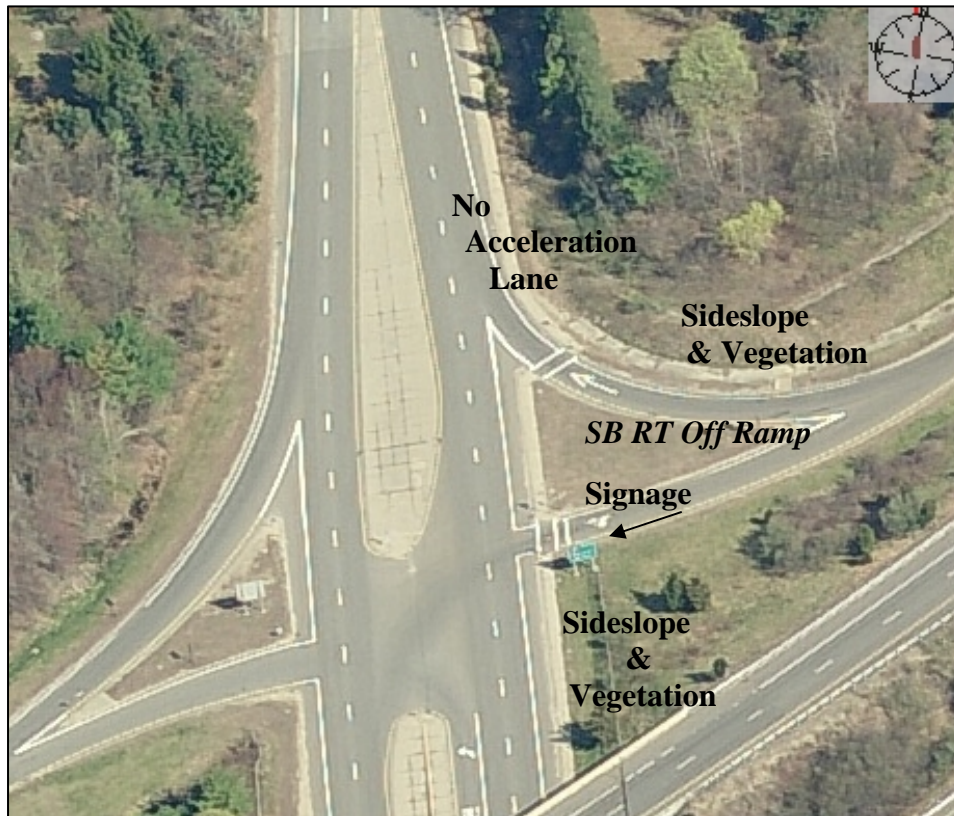
Route I-190 South Bound Off Ramp

MRPC assessed the existing conditions of the south bound (SB) right turn (RT) off ramp intersection with Route 140. This intersection accounts for nearly eighty percent of the crashes that occur at this interchange (see **Chapter 4.0**). This is most likely the result of the following conditions:

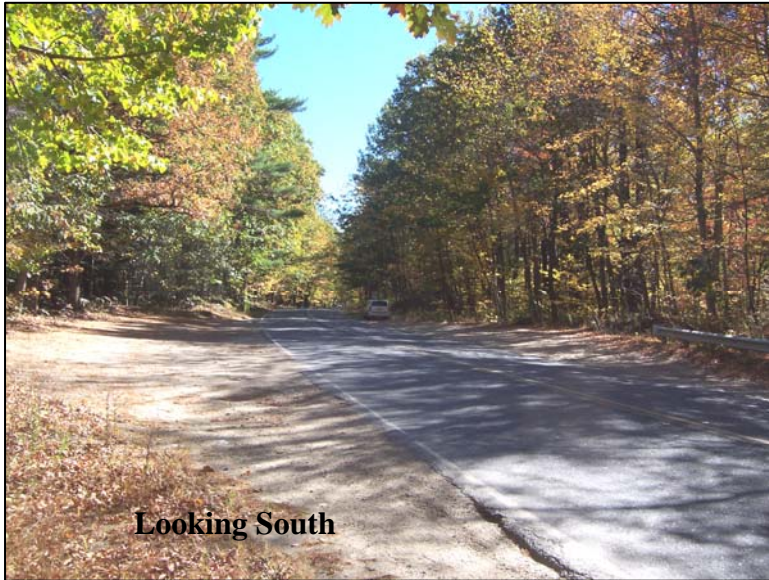
Photos: Bus Turnaround

MRPC assessed the existing conditions of the bus turnaround located at the Princeton TL. The off road turnaround areas on each side of the road are unpaved and deeply rutted. The pavement edge is also deeply rutted in many places. Drivers are most likely unaware of the turnaround as road side vegetation hinders the view and there is no notification or warning through signage or pavement markings that it exists.

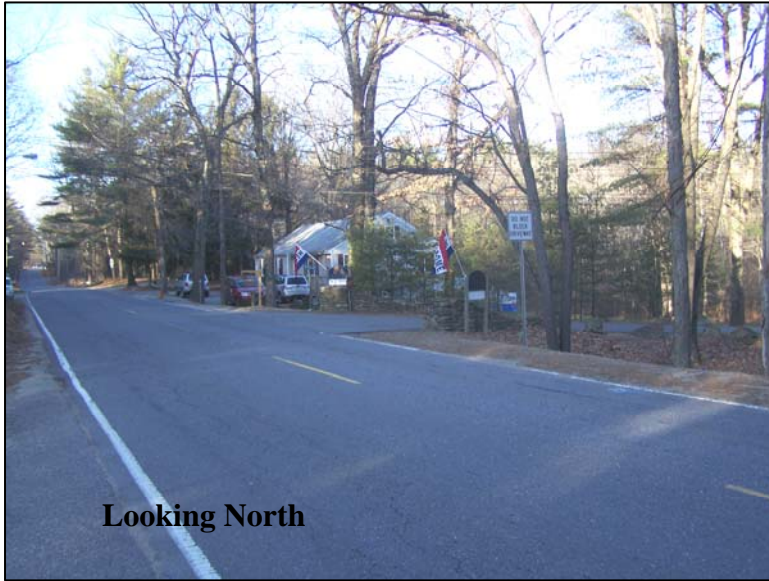
Sterling- Rt 140 Traffic Signs Figure 9-1.1

MRPC conducted traffic sign inventories of regulatory and warning signs and provides key observations to assist in the development of improvement options and setting project priorities. The results are shown on **Figures 9-1.1** and **9-1.2** and listed by location in **Table 9-1** below.

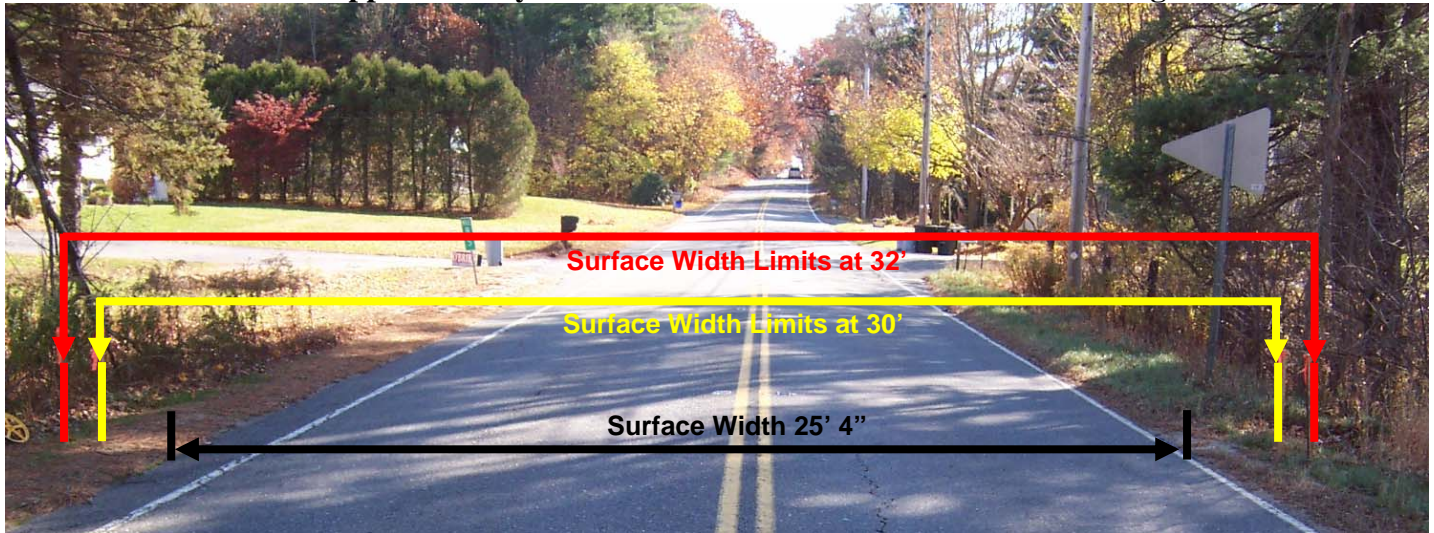
Route 140 Approximately 0.25 miles North of Dana Hill Road – Looking South

Current surface width is approximately 25'4" (as measured in the field). Shoulder for northbound lane approximately 22". Increasing the surface width to 30' or 32' would require extensive tree removal, utility pole relocation, land cutting and filling. Note area to the south where extensive number of trees as well as land grades that would require cutting and potential retaining walls.
