# **Bus Stop ADA Accessibility Evaluation for MART Fitchburg/Leominster Bus Routes**

**September 2021**

Prepared for the Montachusett Regional Transit Authority (MART)

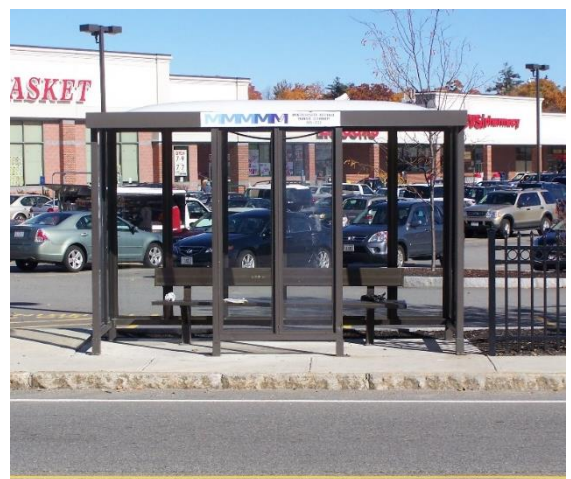
#### Stop Id No. 4 – Water Street Plaza 141 Water Street

On Street; Bus Shelter; Ramp at Corner for Plaza Entrance: 25+ feet away; Marked w/Plate; No Crosswalks at Entrance; None Crossing Water to east side

- Location comment: Stop not connected to a pedestrian route;
- Amenities: NA;
- Crosswalks: None exist;
- Curb Ramps: Two non-compliant ramps exist (due to location and curbing);
- Signal Push Button: None exist;
- Main Landing Pad: None exist;
- Bus Stop Markings: None exist; high traffic volume on street;
- Shelter: Does exist; seating exist; shelter pad in poor condition;
- Sidewalk: Does exist; in good condition; 4'-0" clear path appears to exist;
- Bus Stop Sign: None exist;

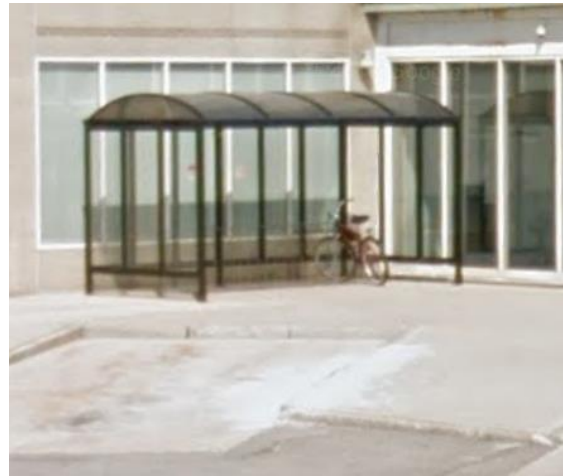
- Location comment: Stop connected to pedestrian route through parking garage;
- Amenities: bike rack shelter; many amenities within MART ITC;
- Crosswalks: None exist;
- Curb Ramps: Ramps exist within garage;
- Signal Push Button: None exist;
- Main Landing Pad: None exist;
- Bus Stop Markings: None exist; bays are marked by curbs;
- Shelter: Does exist; no seating exists; serves as a bicycle shelter;
- Sidewalk: Does exist; in good condition; 4'-0" clear path exist;
- Bus Stop Sign: None exist;

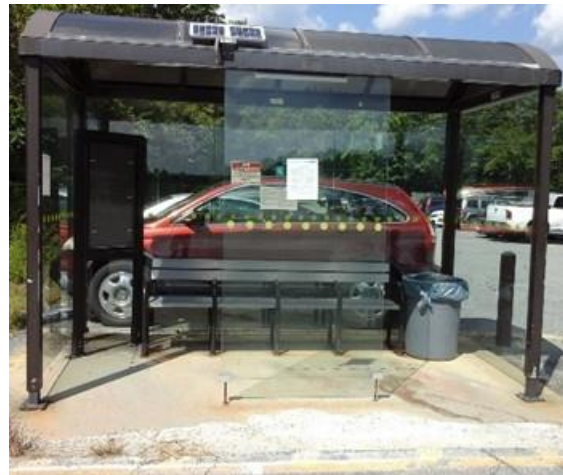
### Stop Id No. 19 – Wallace Civic Center Parking Lot

Shelter just inside Parking Lot norther Entrance/Exit;

- Location comment: Stop not connected to a pedestrian route;
- Amenities: One trash can; one light pole; five trees; one non-operational emergency pole; one empty poster stand;
- Crosswalks: None exist;
- Curb Ramps: None exist;
- Signal Push Button: None exist;
- Main Landing Pad: None exist;
- Bus Stop Markings: None exist;
- Shelter: Does exist; seating exist; accessible wheelchair space exists fully within the width of the roof; shelter pad in poor condition – concrete immediately in front of shelter completely crumbled; vehicles permitted to park within inches of back of shelter; existing barrier post are insufficient protection from a crash; shelter columns appear to be poorly mounted; moveable trash can reduces accessible wheelchair space;
- Sidewalk: None exist;
- Bus Stop Sign: None exist;

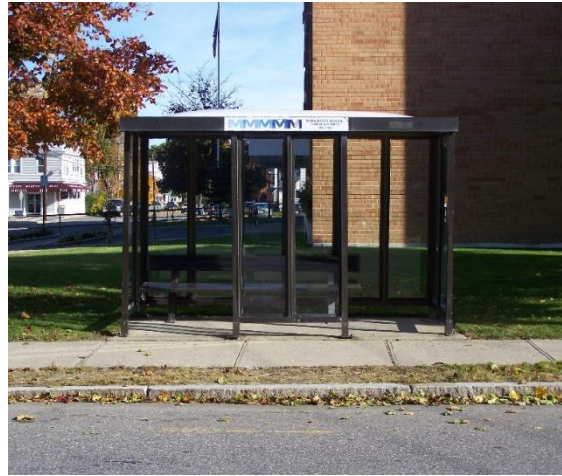
### Stop Id No. 27 – LaPierre Building East, Senior Living Building

Corner of 4th St/Spruce St; Shelter on 4th St; Sidewalk at shelter; Approx. 20 - 30 ft from corner 4th/Spruce; ramp on corner; marked ramp; Crosswalk across 4th St

- Location comment: Stop not fully connected to a pedestrian route;
- Amenities: One light pole, two trees; two utility poles;
- Crosswalks: One non-compliant crosswalk exist perpendicular to stop; none exist parallel to stop;
- Curb Ramps: Four non-compliant ramps exist;
- Signal Push Button: None exist;
- Main Landing Pad: None exist;
- Bus Stop Markings: None exist;
- Shelter: Does exist; seating exist; accessible wheelchair space exists fully within the width of the roof;
- Sidewalk: Does exist; in good condition; 4'-0" clear path exists;
- Bus Stop Sign: None exist;

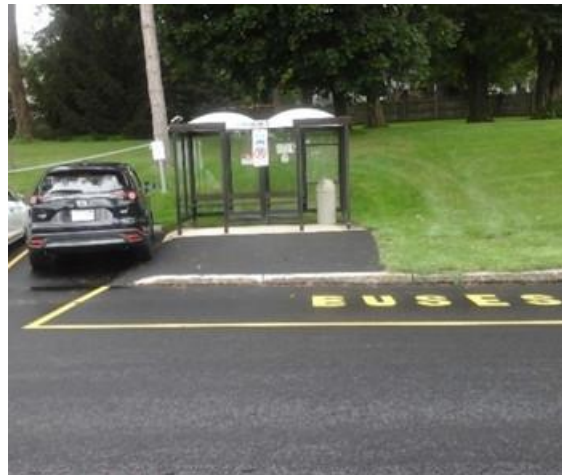
### Stop Id No. 29 – Leominster Senior Center

Shelter on West St approximately 45 - 50 ft from corner w/Pond St; Ramp on corner; marked ramp; Crosswalks on Pond St and West St at corner; Ramp approximately 110 ft north on West St w/marked ramp and crosswalk;

- Location comment: NA
- Amenities: One trash can, two light poles, two trees, two utility poles; **moveable trash can reduces accessible wheelchair space;**
- Crosswalks: One exist perpendicular to stop; two exist parallel to stop;
- Curb Ramps: Five ramps exist;
- Signal Push Button: None exist;
- **Main Landing Pad: None exist;**
- Bus Stop Markings: None exist;
- Shelter: Does exist; seating exist; accessible wheelchair space exists fully within the width of the roof; **moveable trash can reduces accessible wheelchair space;**
- Sidewalk: Does exist; in good condition; 4'-0" clear path exists;
- Bus Stop Sign: None exist;

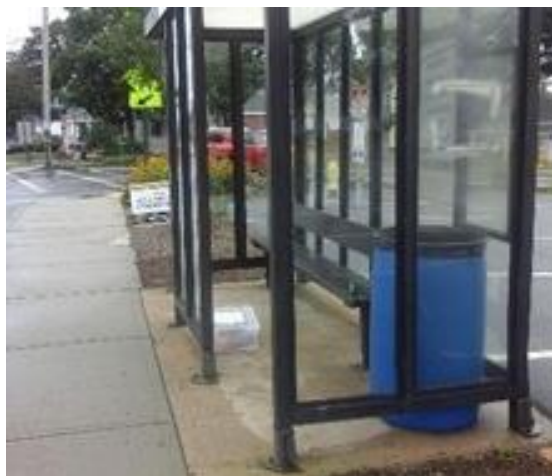
### Stop Id No. 28 – Leominster Hospital

Shelter on Memorial Drive; Set back approx. 10 ft; Marked bus stop location on Memorial Dr approximately 40 ft x 9 ft; No sidewalk or crosswalk;

Priority Rank	Stop ID No.	Bus Stop Location	Recommendations (Sidewalk (SW) = not accessible pedestrian route)
1	28	Leominster Hospital	Connect to a PAR using SW on Memorial Dr by adding CWs & ACRs; eliminate parking space abutting CR & LP; correct slope of LP to 2%; clear shelter CFA of trash can
2	50	Water Tower Plaza	Add ACRs to SW at CW; correct LP size
3	3	Central Plaza - 130 Water Street	Add accessible CWs & ACRs to SW; correct LP size; add ACR to parking lot
4	7	Erdman Way	Add PAR to shelter; correct LP size
5	46	Wachusett Station	Complete PAR by adding CWs where needed & DWPs to CR
6	39	Parkhill Plaza	Connect to a PAR by widening SW, adding CWs & ACRs; add LP
7	29	Leominster Senior Center	Add LP; clear shelter CFA of trash can
8	4	Water Street Plaza - 141 Water Street	Connect to a PAR by adding CWs & ACRs; add LP
9	27	LaPierre Building	Connect to a PAR by adding CWs & ACRs; add LP
10	19	Wallace Civic Center Parking Lot	Connect to a PAR by adding CWs & ACRs (or only DWPs) as needed; add LP; redesign shelter to address poor condition; clear shelter CFA of trash can

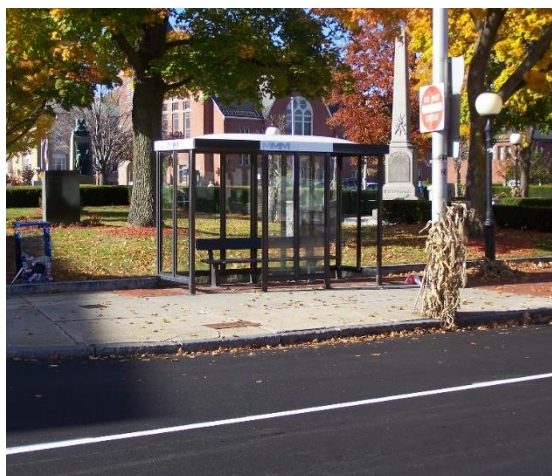
### Stop Id No. 36 – Monument Square Main St

Monument Square serves as Main Transit Point within the City of Leominster; All bus routes begin/end at Monument Square either at Main Street or West Street shelter; Shelter approximately 30 feet north of Main Street/Park Street north corner; Several benches also exist along sidewalk around park; Sidewalk approximately 12 feet in width at Shelter; Although not specifically marked, an approximately 10 foot lane exists on Main Street between West Street and Park Street parallel to west sidewalk that is used for bus stoppage and storage;

- Location comment: NA;
- Amenities: Two trash cans, one hydrant, two light poles, one planter, two trees; two utility poles;
- Crosswalks: One exist parallel to stop; three additional crosswalks exist;
- **Curb Ramps: Eight ramps exist of which one is non-compliant;**
- **Signal Push Button: Eight non-compliant signal push buttons exist;**
- **Main Landing Pad: Does exist; light pole blocks full length;**
- Bus Stop Markings: None exist;
- Shelter: Does exist; seating exist; accessible wheelchair space exists fully within the width of the roof;
- Sidewalk: Does exist; in good condition; 4'-0" clear path exists;
- Bus Stop Sign: None exist;

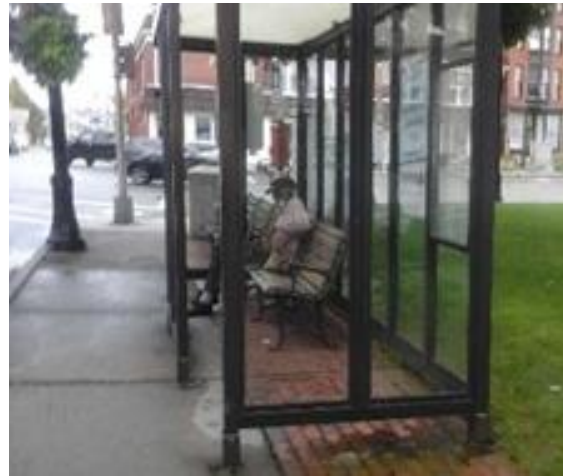
### Stop Id No. 37 – Monument Square West St

Along with Monument Square Main Street, this Shelter on West Street on Monument Square serves as the Main Transit Point within the City of Leominster; All bus routes begin/end at Monument Square either at Main Street or West Street shelter; Shelter approximately 30 feet west of Main Street/West Street south corner; Benches exist along sidewalk around park; Sidewalk approximately 4 to 6 feet in width at Shelter; West Street has 2 travel lanes for east/west bound traffic; Travel lane in front of shelter approximately 18 to 20 feet in width; Allows traffic to pass around stopped buses; On Street parking permitted on north side of West Street from Main Street intersection; On Street Parking begins approximately 60 feet west of shelter;

- Location comment: NA;
- Amenities: one trash can, one light pole, one planter, one tree;
- Crosswalks: One exist perpendicular to stop; one exists parallel to stop; two additional crosswalks exist;
- Curb Ramps: Eight ramps exist;
- Signal Push Button: Eight non-compliant signal push buttons exist;
- Main Landing Pad: None exist;
- Bus Stop Markings: None exist;
- Shelter: Does exist; seating exist; accessible wheelchair space exists fully within the width of the roof;
- Sidewalk: Does exist; in good condition; 4'-0" clear path exists;
- Bus Stop Sign: None exist;

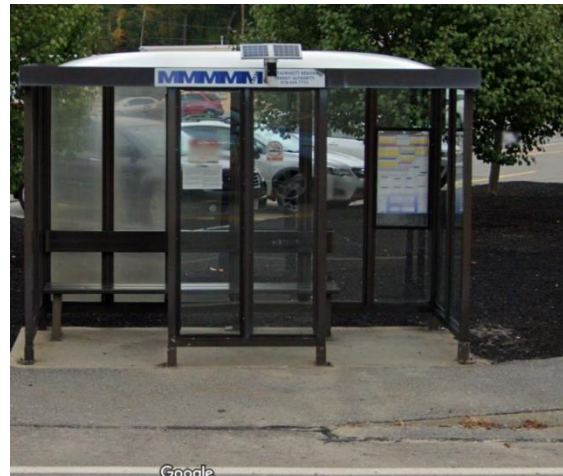
### Stop Id No. 39 – Parkhill Plaza

Shelter on Electric Ave approx. 25 ft from Plaza Entrance/Exit; No curbing in front of Shelter; Inconsistent Sidewalk on north and south sides of Electric Ave; No crosswalks; Utility Pole less than 10 ft east of Shelter impacts sidewalk width and flow;

- Location comment: Stop not connected to a pedestrian route;
- Amenities: NA;
- Crosswalks: None exist;
- Curb Ramps: One non-compliant ramp exists;
- Signal Push Button: None exist;
- Main Landing Pad: None exist;
- Bus Stop Markings: None exist;
- Shelter: Does exist; seating exist;
- Sidewalk: Does exist; 4'-0" clear path does not appear to exist;
- Bus Stop Sign: None exist;

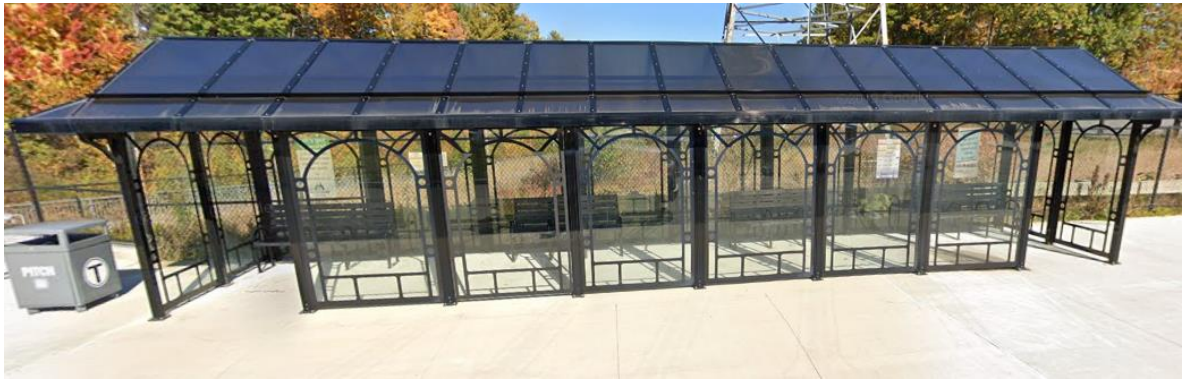
### Stop Id No. 46 – Wachusett Station

Shelter; Train Station; No ramps near Shelter; Ramps approximately 60 - 70 ft at Drop Off location; No Ramp markings; Posts spaced 5 ft apart for 65 ft; Buses signage near Shelter;

- Location comment: NA;
- Amenities: Two trash cans; two bicycle racks, seven light poles;
- Crosswalks: None exist;
- Curb Ramps: One non-compliant ramp exist;
- Signal Push Button: None exist;
- Main Landing Pad: Does exist;
- Bus Stop Markings: None exist;
- Shelter: Does exist; seating exist; accessible wheelchair space exists fully within the width of the roof;
- Sidewalk: Does exist; in good condition; 4'-0" clear path exists;
- Bus Stop Sign: Does exist

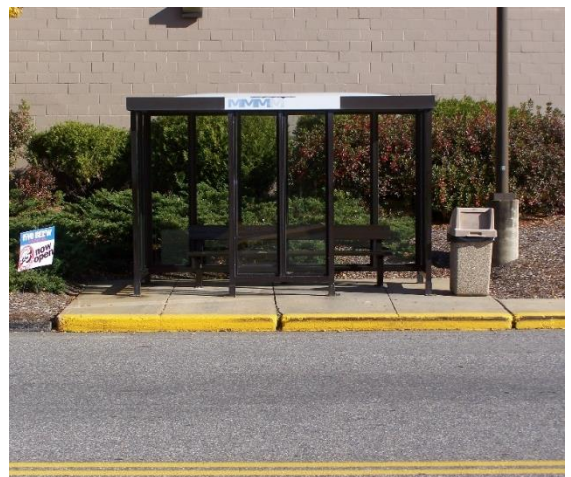
- Location comment: NA;
- Amenities: One trash can, one hydrant, one light pole; two trees;
- Crosswalks: One exists parallel (diagonally) to stop; none exist perpendicular to stop;
- Curb Ramps: Two non-compliant ramps exist;
- Signal Push Button: None exist;
- Main Landing Pad: None exist;
- Bus Stop Markings: None exist;
- Shelter: Does exist; seating exist; accessible wheelchair space exists fully within the width of the roof;
- Sidewalk: Does exist; in good condition; 4'-0" clear path exists;
- Bus Stop Sign: None exist;

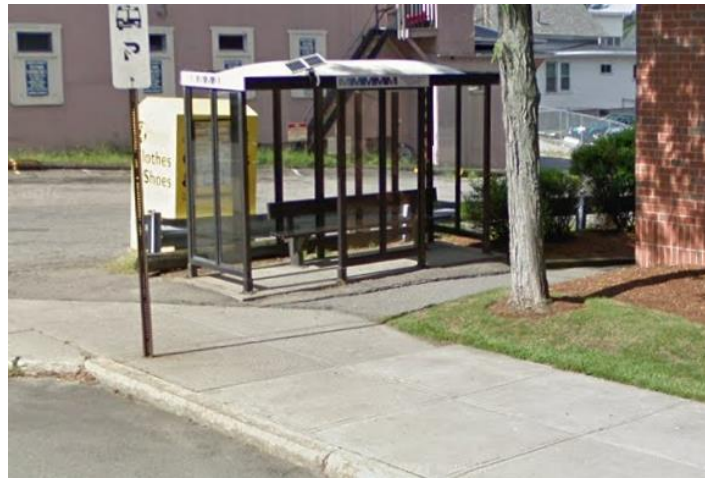
- Location comment: NA;
- Amenities: NA;
- Crosswalks: None exist;
- Curb Ramps: two non-compliant ramp exist approximately 570' north of Stop; two non-compliant ramp exist approximately 420' south of Stop;
- Signal Push Button: None exist;
- Main Landing Pad: None exist;
- Bus Stop Markings: None exist;
- Shelter: Does exist; seating exist; not accessible – shelter pad threshold is significantly higher than the existing paved area; paved area not level;
- Sidewalk: Does exist; in fair condition; 4'-0" clear path exists;
- Bus Stop Sign: Does exist;
- Bus Pull Out On Street

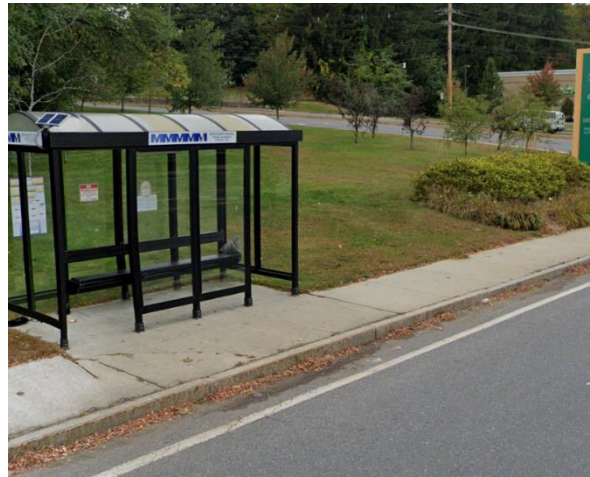
### Stop Id No. FD-2 Water Street at Bemis Road

Shelter located on Water Street abutting southbound travel lane; Approximately 100 feet south of Wanoosnoc Road intersection with Water Street;

- Location comment: NA;
- Amenities: NA;
- Crosswalks: One exist nearby parallel to stop; one exists nearby perpendicular to stop;
- **Curb Ramps: six non-compliant ramp exists at nearby crosswalks;**
- Signal Push Button: None exist;
- **Main Landing Pad: None exist;**
- Bus Stop Markings: None exist;
- Shelter: Does exist; seating exist;
- Sidewalk: Does exist; in fair condition; 4'-0" clear path exists;
- Bus Stop Sign: None exist;

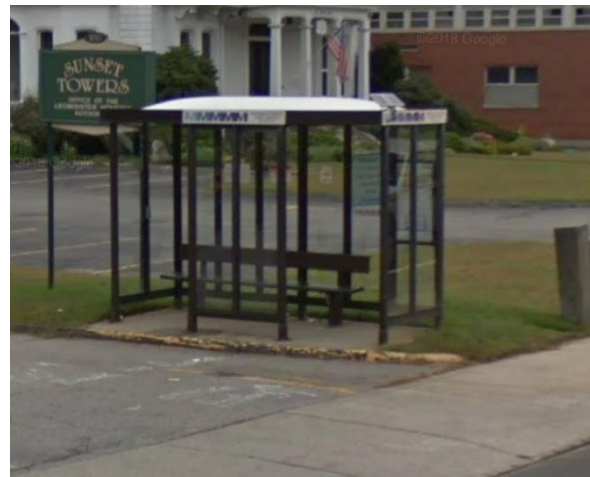
### Stop Id No. FD-3 Sunset Towers Main Street

Located perpendicular to southbound travel lane of Main Street in Leominster; Serves Sunset Towers senior living Apartments;

- **Location comment: Stop not connected to a pedestrian route;**
- Amenities: NA;
- Crosswalks: One exist exists nearby parallel to stop; one exists nearby perpendicular to stop;
- **Curb Ramps: None exist;**
- Signal Push Button: None exist;
- **Main Landing Pad: None exist;**
- Bus Stop Markings: None exist;
- **Shelter: Does exist; seating exist; not accessible – Curb blocks accessibility;**
- Sidewalk: Does exist; in fair condition; 4'-0" clear path exists;
- Bus Stop Sign: None exist;

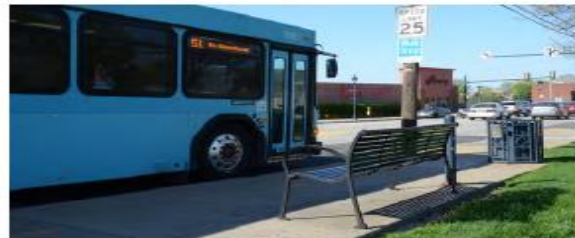
Bench Stop on Brownsville Road opposite Dewalt Avenue

PAAC adds a bench and amenities to the landing pad and bus stop sign. The bench and amenities must not be placed within the landing pad ADA minimum required design dimensions.

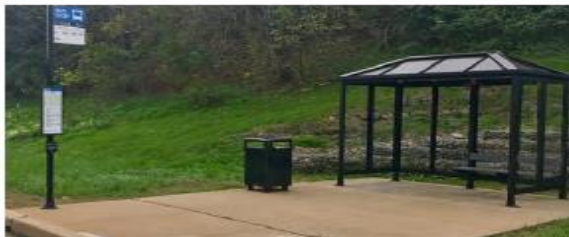
South Busway at Pioneer Avenue Ramp

PAAC adds a passenger shelter to the landing pad, bus stop sign, bench, and amenities. The shelter must meet the ADA minimum required design dimensions for a shelter.

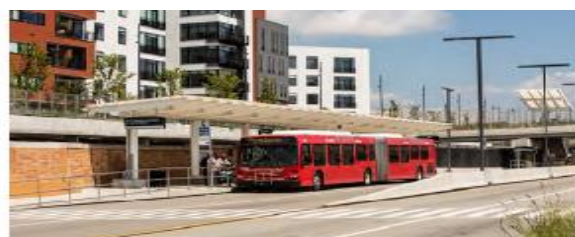
East Liberty Station

In the MRPC region, station bus stops are associated with the MBTA Commuter Rail (Wachusett Commuter Rail Station, Leominster Commuter Rail Station, Fitchburg Commuter Rail Station at the Fitchburg ITC). In many ways, these bus stops should enhance and exceed the ADA minimum required design dimensions for the landing pad, stop sign, shelter, and amenities.

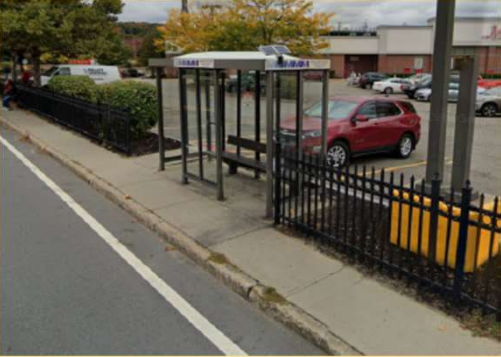
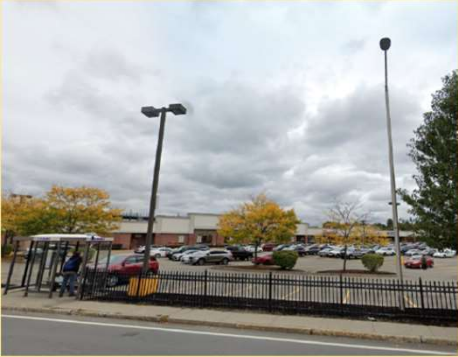
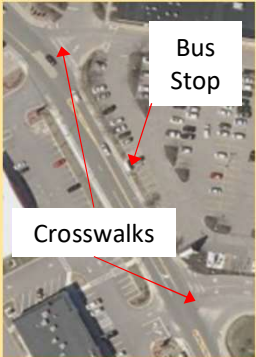
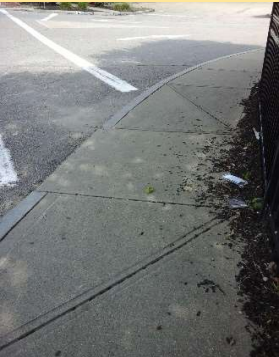
ID 4 Bus Stop Field Survey Results

What is the slope of the level landing parallel to the curb (%)?		
What is the length of the level landing perpendicular to the curb (in)?		
What is the slope of the level landing perpendicular to the curb (%)?		
What is the counter slope of the gutter perpendicular to the curb (%)?		
What is the vertical change at the ramp connection to the roadway (in)?		
Is there a detectable warning panel?		
Is the curb ramp within the crosswalk?		
Additional curb ramp comments		Non Compliant Ramp (no detectable warning panel & no level landing area) exist at north Crosswalk

Is there an additional curb ramp present?	No	 
What is the width of the ramp (in)?		
What is the cross slope of the curb ramp (%)?		
What is the running slope of the curb ramp (%)?		
Is there a level landing area?		
What is the width of the level landing parallel to the curb (in)?		
What is the slope of the level landing parallel to the curb (%)?		
What is the length of the level landing perpendicular to the curb (in)?		
What is the slope of the level landing perpendicular to the curb (%)?		
What is the counter slope of the gutter perpendicular to the curb (%)?		
What is the vertical change at the ramp connection to the roadway (in)?		
Is there a detectable warning panel?		
Is the curb ramp within the crosswalk?		
Additional curb ramp comments	No ramp to parking lot at shelter. Non Compliant Ramp (no detectable warning panel & no level landing area) exist at south Crosswalk	
Does a signal push button exist?	No

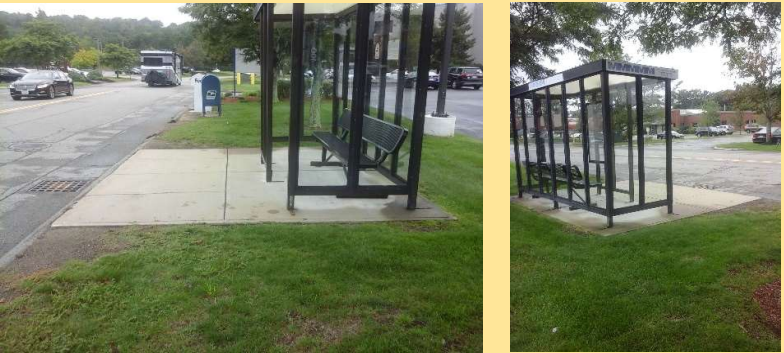
ID 7 Bus Stop Field Survey Results

What is the distance from the shelter to the back of the sidewalk or building (in)?	
Is there an accessible wheelchair space fully within the width of the roof?	Yes
Does the shelter impede pedestrian flow?	No
Is the bus schedule posted within the shelter?	No
Additional shelter comments	Front glass panes missing
Is a sidewalk present?	No
What is the narrowest width of the sidewalk (in)?	
Does all of the bus stop have a 4'-0" clear path?	
What length of the bus stop has a 4'-0" clear path (ft)?	
What is the condition of the sidewalk?	
What is the material of the sidewalk?	
Is there an MBTA station within sight distance?	
Additional sidewalk comments	Bus Stop not connected to a pedestrian route
Is an additional sidewalk present?	
What is the narrowest width of the sidewalk (in)?	
Does all of the bus stop have a 4'-0" clear path?	
What length of the bus stop has a 4'-0" clear path (ft)?	
What is the condition of the sidewalk?

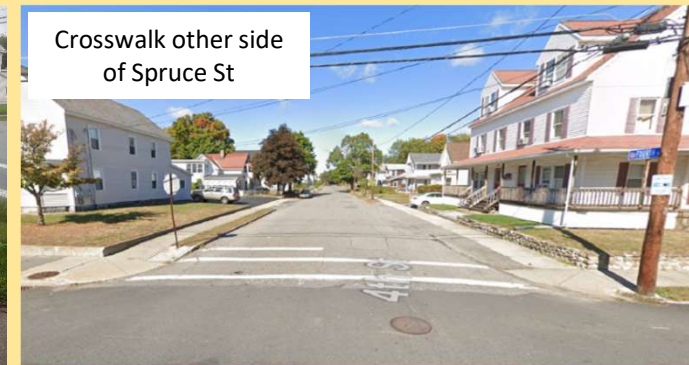
Crosswalk other side of Spruce St

Additional curb ramp comments	
Is there an additional curb ramp present?	Yes
What is the width of the ramp (in)?	
What is the cross slope of the curb ramp (%)?	
What is the running slope of the curb ramp (%)?	
Is there a level landing area? Yes	
What is the width of the level landing parallel to the curb (in)?	
What is the slope of the level landing parallel to the curb (%)?	
What is the length of the level landing perpendicular to the curb (in)?	
What is the slope of the level landing perpendicular to the curb (%)?	
What is the counter slope of the gutter perpendicular to the curb (%)?	
What is the vertical change at the ramp connection to the roadway (in)?	
Is there a detectable warning panel? Yes	
Is the curb ramp within the crosswalk? No	
Additional curb ramp comments	
There are 2 additional ramps on Fourth St on other side of Spruce St. No crosswalks across Spruce St to create pedestrian route	
Does a signal push button exist?	No

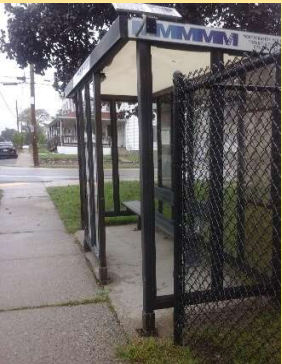
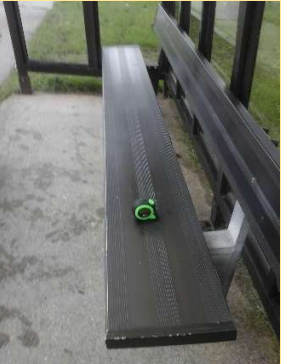
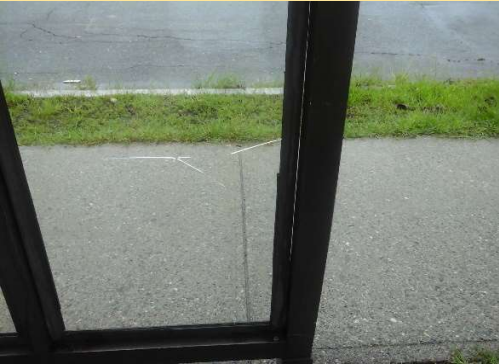
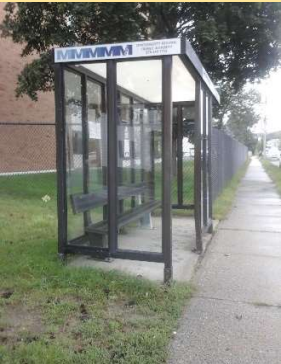
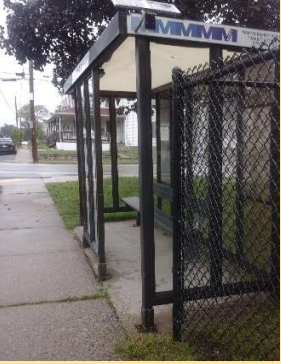
ID 27 Bus Stop Field Survey Results

What is the condition of the seating?	Good
What is the height of the seating (in)?	
What is the distance from the back of the curb to the front of the shelter (in)?	
What is the distance from the shelter to the back of the sidewalk or building (in)?	
Is there an accessible wheelchair space fully within the width of the roof?	Yes
Does the shelter impede pedestrian flow?	No
Is the bus schedule posted within the shelter?	No
Additional shelter comments	Damage to front glass pane of shelter
Is a sidewalk present?	Yes
What is the narrowest width of the sidewalk (in)?	
Does all of the bus stop have a 4'-0" clear path?	Yes
What length of the bus stop has a 4'-0" clear path (ft)?	
What is the condition of the sidewalk?	Good
What is the material of the sidewalk?	Concrete
Is there an MBTA station within sight distance?	No
Additional sidewalk comments	Grass growing between concrete panels
Is an additional sidewalk present?	No

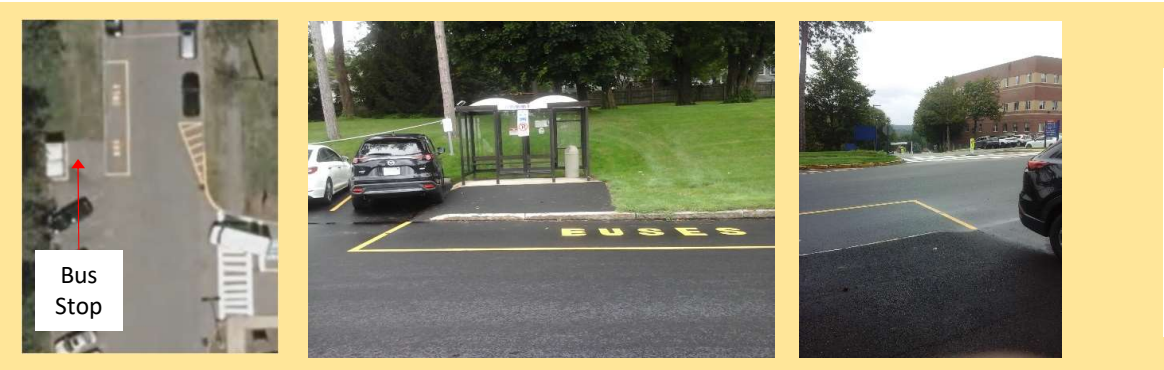
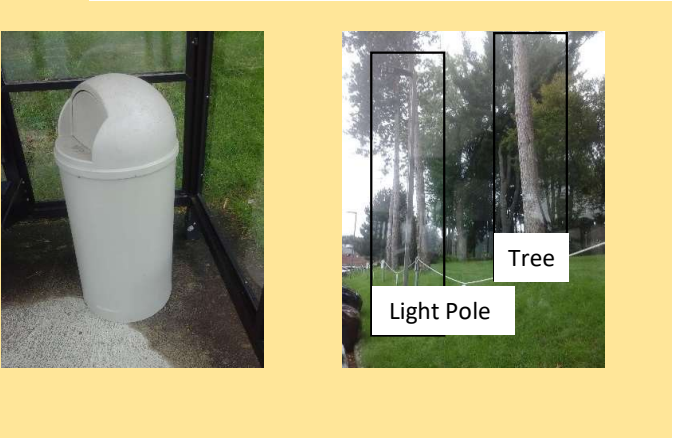
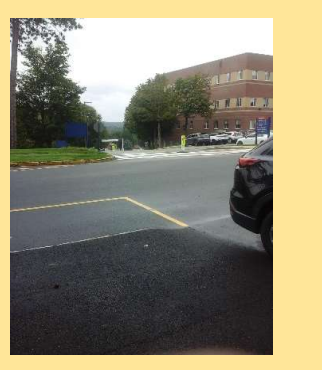
ID 28 Bus Stop Field Survey Results

Do any of the utility poles reduce the clear path of travel to 36 inches or less?	
How many other static amenities are there?	
Additional amenity comments	Moveable trash reduces accessible wheelchair space
Are crosswalk markings present?	No
What is the condition of the crosswalk markings?	
Other - What is the condition of the crosswalk markings?	
Crossing orientation to route	
Other - Crossing orientation to route	
Additional crossing comments	Bus Stop not connected to a pedestrian route
Are additional crosswalk markings present?	Yes
What is the condition of the crosswalk markings?	
Other - What is the condition of the crosswalk markings?	
Crossing orientation to route	
Other - Crossing orientation to route	
Additional crossing comments	Crosswalk on intersecting street
Is there a curb ramp present?	Yes
What is the width of the ramp (in)?	
What is the cross slope of the curb ramp (%)?	
What is the running slope of the curb ramp (%)?

Is there a level landing area?	No
What is the width of the level landing parallel to the curb (in)?	
What is the slope of the level landing parallel to the curb (%)?	
What is the length of the level landing perpendicular to the curb (in)?	
What is the slope of the level landing perpendicular to the curb (%)?	
What is the counter slope of the gutter perpendicular to the curb (%)?	
What is the vertical change at the ramp connection to the roadway (in)?	
Is there a detectable warning panel?	No
Is the curb ramp within the crosswalk?	No
Additional curb ramp comments	Ramp not accessible and can be easily blocked by parked vehicle. Bus Stop not connected to a pedestrian route
Is there an additional curb ramp present?	No
What is the width of the ramp (in)?	
What is the cross slope of the curb ramp (%)?

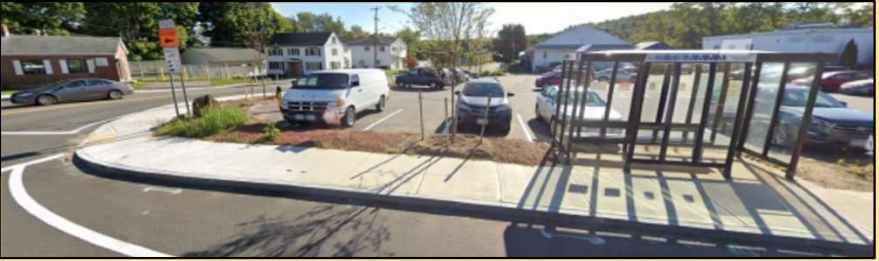
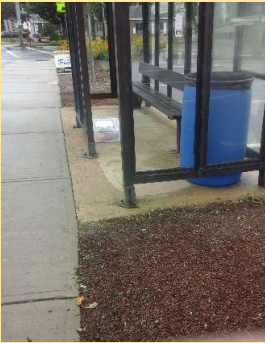
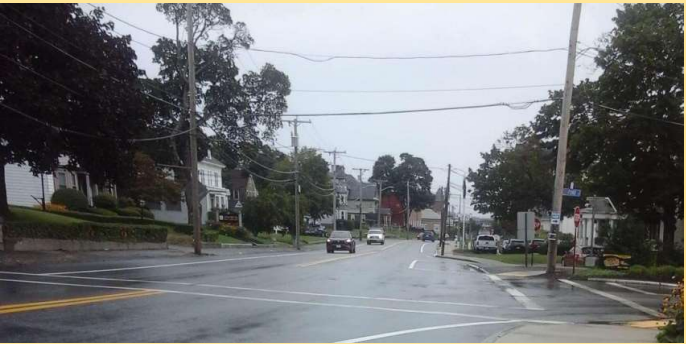
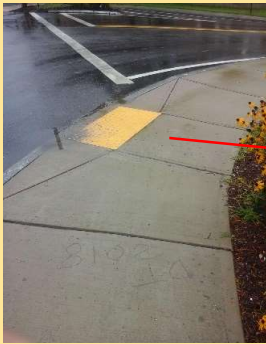
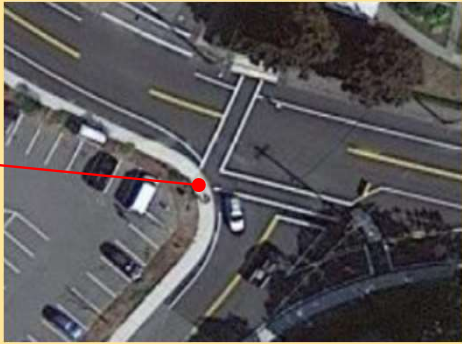
ID 29 Bus Stop Field Survey Results

How many other static amenities are there?	3
Additional amenity comments	Moveable trash reduces accessible wheelchair space
Are crosswalk markings present?	Yes
What is the condition of the crosswalk markings?	Good
Other - What is the condition of the crosswalk markings?	
Crossing orientation to route	Across
Other - Crossing orientation to route	
Additional crossing comments	
Are additional crosswalk markings present?	Yes
What is the condition of the crosswalk markings?	Good
Other - What is the condition of the crosswalk markings?	
Crossing orientation to route	Across
Other - Crossing orientation to route	
Additional crossing comments	A total of 1 additional crosswalk creates pedestrian route
Is there a curb ramp present?	Yes
What is the width of the ramp (in)?	
What is the cross slope of the curb ramp (%)?	
What is the running slope of the curb ramp (%)?	
Is there a level landing area?	Yes
What is the width of the level landing parallel to the curb (in)?

What is the slope of the level landing parallel to the curb (%)?	
What is the length of the level landing perpendicular to the curb (in)?	
What is the slope of the level landing perpendicular to the curb (%)?	
What is the counter slope of the gutter perpendicular to the curb (%)?	
What is the vertical change at the ramp connection to the roadway (in)?	
Is there a detectable warning panel?	Yes
Is the curb ramp within the crosswalk?	Yes
Additional curb ramp comments	Evidence of ponding at bottom of ramp (in turning area)

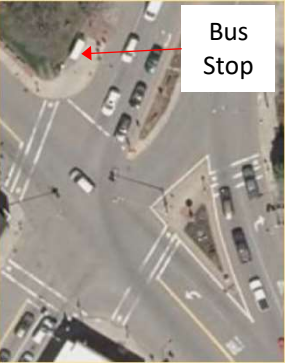
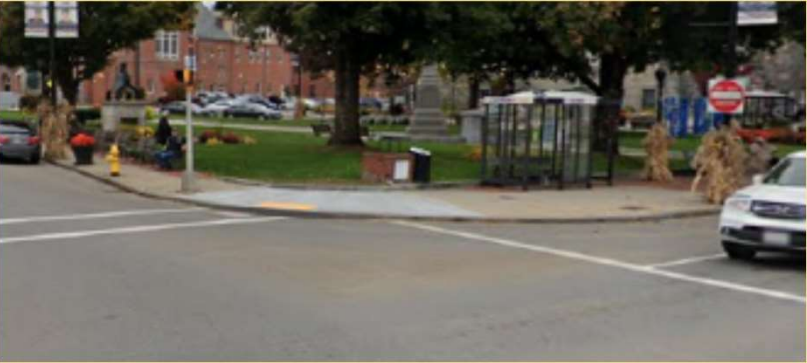
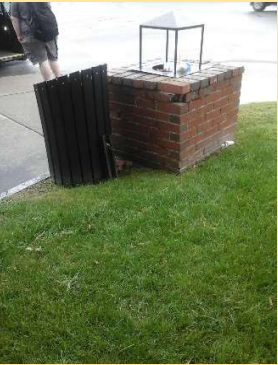
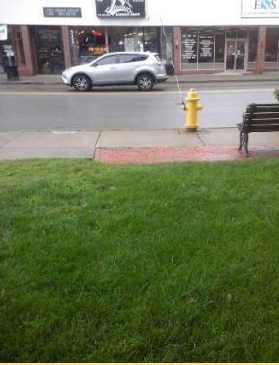
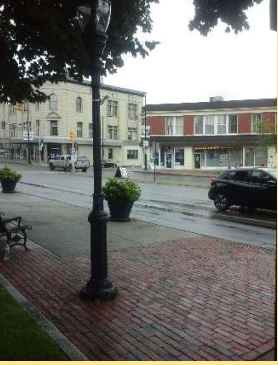
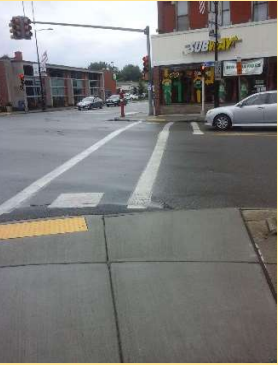
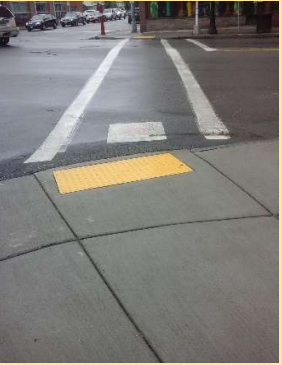
ID 36 Bus Stop Field Survey Results

How many other static amenities are there?	
Additional amenity comments	Light pole blocks full length of landing pad
Are crosswalk markings present?	Yes
What is the condition of the crosswalk markings?	Good
Other - What is the condition of the crosswalk markings?	
Crossing orientation to route	Diagonal
Other - Crossing orientation to route	
Additional crossing comments	
Are additional crosswalk markings present?	Yes
What is the condition of the crosswalk markings?	Good
Other - What is the condition of the crosswalk markings?	
Crossing orientation to route	Across
Other - Crossing orientation to route	
Additional crossing comments	A total of 2 additional crosswalks at intersection creates a pedestrian route
Is there a curb ramp present?	Yes
What is the width of the ramp (in)?	
What is the cross slope of the curb ramp (%)?	
What is the running slope of the curb ramp (%)?	
Is there a level landing area?	Yes
What is the width of the level landing parallel to the curb (in)?

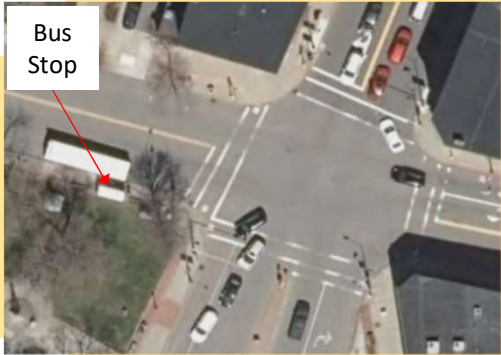
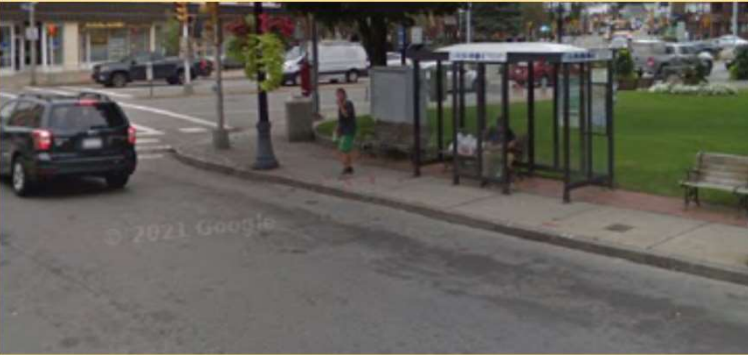
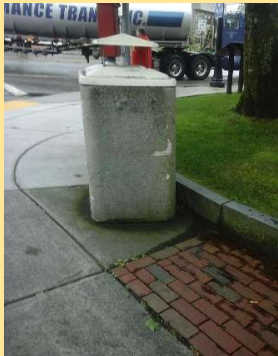
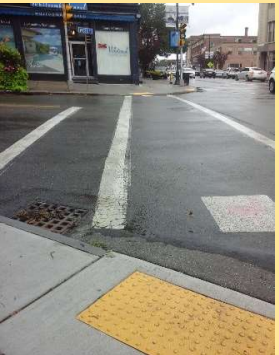
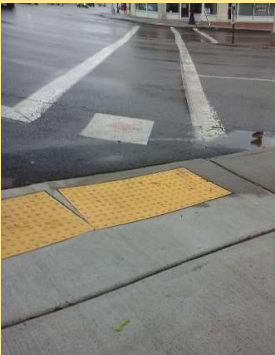
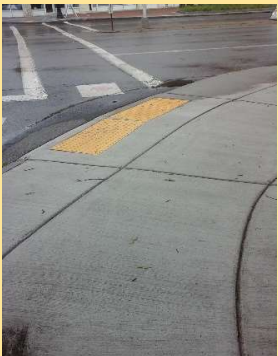
ID 37 Bus Stop Field Survey Results

How many other static amenities are there?	
Additional amenity comments	
Are crosswalk markings present?	Yes
What is the condition of the crosswalk markings?	Fair
Other - What is the condition of the crosswalk markings?	
Crossing orientation to route	Across
Other - Crossing orientation to route	
Additional crossing comments	
Are additional crosswalk markings present?	Yes
What is the condition of the crosswalk markings?	Fair
Other - What is the condition of the crosswalk markings?	
Crossing orientation to route	Across
Other - Crossing orientation to route	
Additional crossing comments A total of 2 additional crosswalks at intersection creates a pedestrian route	
Is there a curb ramp present?	Yes
What is the width of the ramp (in)?	
What is the cross slope of the curb ramp (%)?	
What is the running slope of the curb ramp (%)?	
Is there a level landing area?	Yes
What is the width of the level landing parallel to the curb (in)?

What is the slope of the level landing parallel to the curb (%)?	
What is the length of the level landing perpendicular to the curb (in)?	
What is the slope of the level landing perpendicular to the curb (%)?	
What is the counter slope of the gutter perpendicular to the curb (%)?	
What is the vertical change at the ramp connection to the roadway (in)?	
Is there a detectable warning panel?	Yes
Is the curb ramp within the crosswalk?	Yes
Additional curb ramp comments Evidence of ponding at bottom of ramp (in turning area)

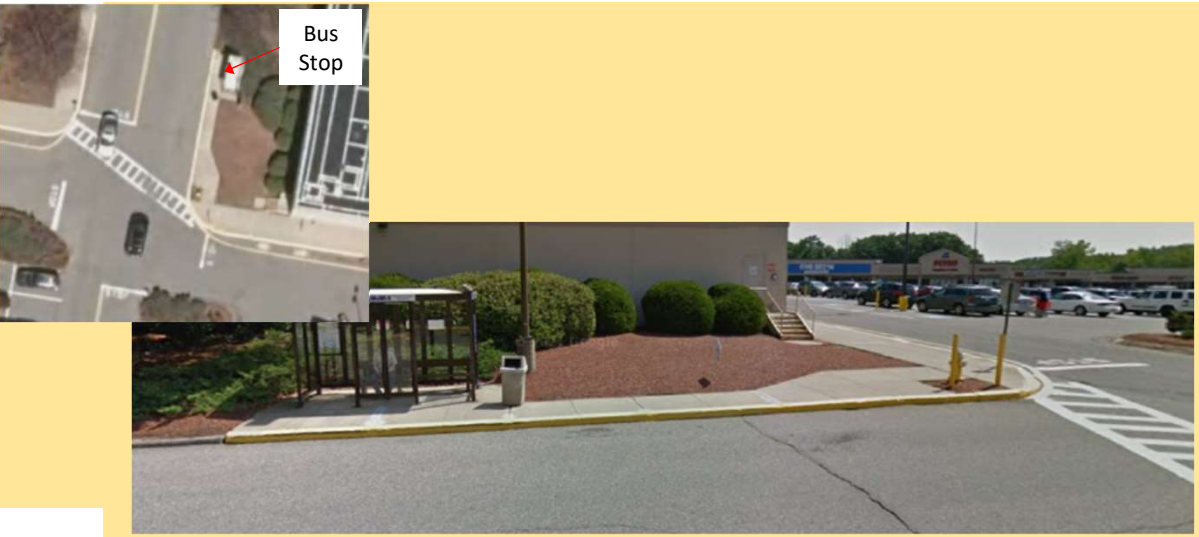
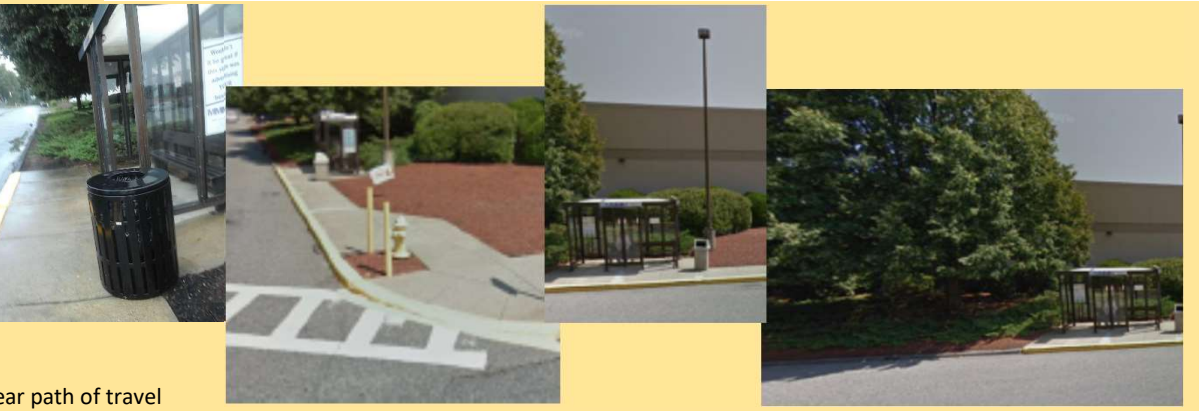
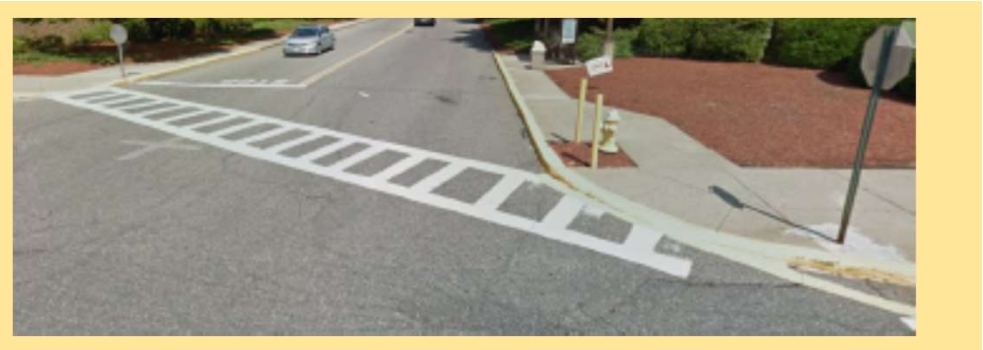
ID 50 Bus Stop Field Survey Results

What is the width of the level landing parallel to the curb (in)?	
What is the slope of the level landing parallel to the curb (%)?	
What is the length of the level landing perpendicular to the curb (in)?	
What is the slope of the level landing perpendicular to the curb (%)?	
What is the counter slope of the gutter perpendicular to the curb (%)?	
What is the vertical change at the ramp connection to the roadway (in)?	
Is there a detectable warning panel?	No
Is the curb ramp within the crosswalk?	No
Additional curb ramp comments	Bottom clear space/turning area not adequate. Level landing inadequate. Evidence of ponding at bottom of ramp (in turning area)
